Jeep Grand Cherokee

Rear Wheel Bearing Replacement

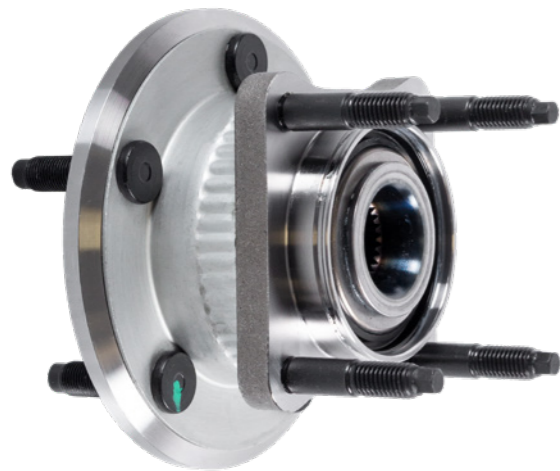
Figure 1

The preassembled febi wheel bearing kit 177041 was chosen for this repair. This comes complete with wheel and axle studs and the bearing is preloaded and greased ready for assembly to the vehicle. (Fig. 1)

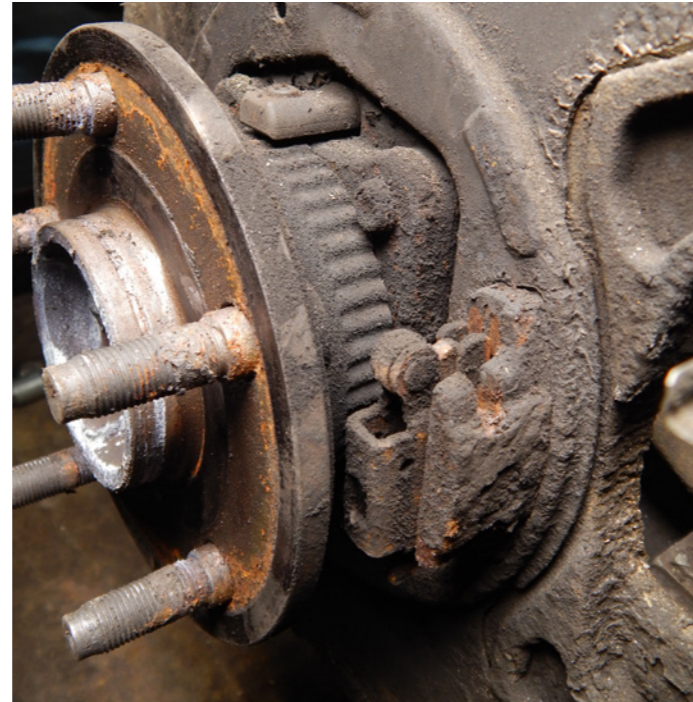
Figure 2

The handbrake actuator lever was removed from the cable, inspected, and checked for excess corrosion and freeness of operation. (Fig. 2)

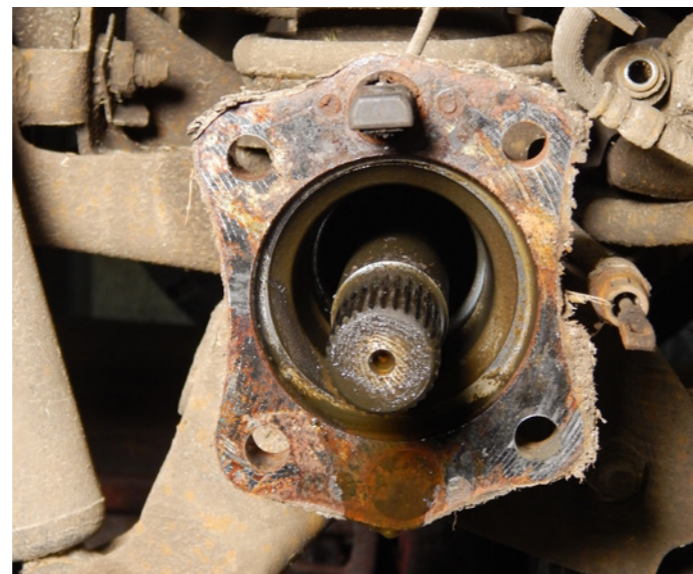
Figure 3

With all the brake components removed, the four retaining nuts that retain the bearing assembly to the axle were unbolted. The bearing assembly then came away, leaving the ABS wheel speed sensor in place. (Fig. 3) However, the brake shoe backing plate and brake caliper carrier remained attached. In some instances, there is also a possibility that the half shaft also remains attached, which then requires sliding out of the bearing and reinserting back into the differential in the axle.

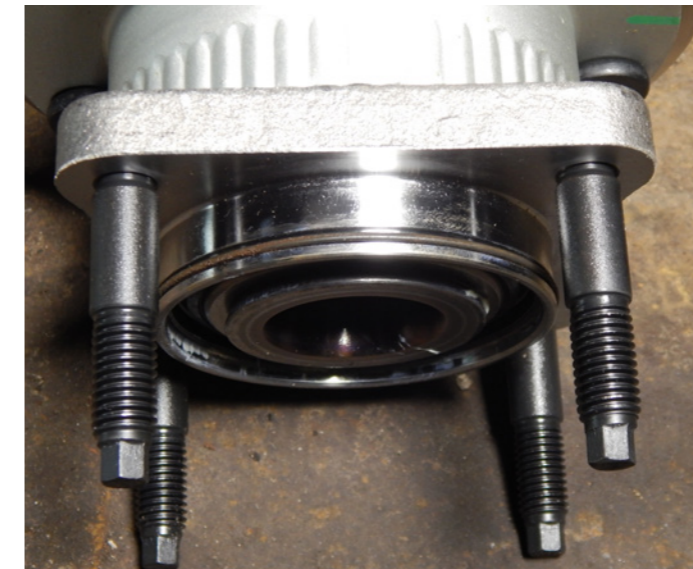
Figure 4

Once all the parts were ready for assembly, they were fitted to the new bearing assembly along with the "O" ring seal positioned in the retaining groove on the bearing (Fig. 4).

Note: Failure to fit this "O" ring can cause axle oil to leak past the bearing, affecting the brake shoe linings.

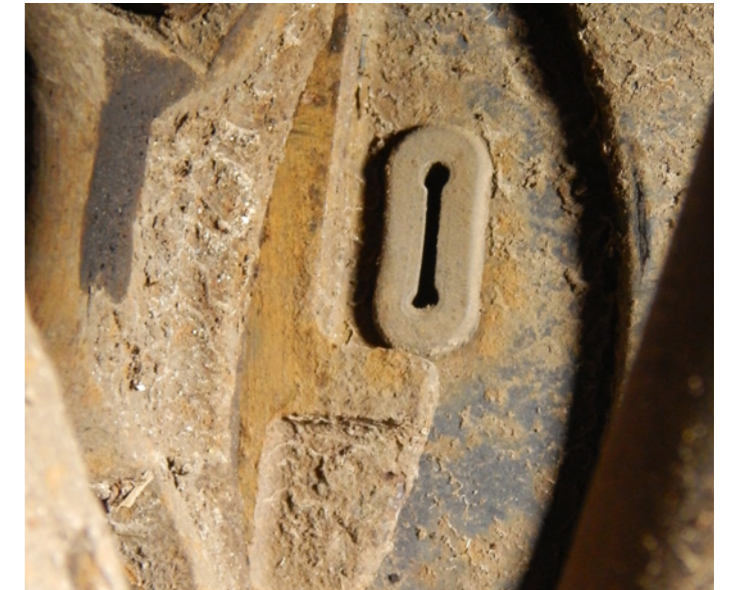
Figure 5

Note: If any adjustment is required, remove the plug from the access hole in the brake back plate. (Fig. 5) Then, loosen the parking brake cable adjustment nut until there is slack.

A suitable adjusting tool should be inserted through the back plate access hole to engage a tool in the teeth of the adjusting wheel. Rotate the adjuster until a slight drag can be felt when the road wheel is rotated.

Push and hold the adjuster lever away from the adjuster wheel with a thin screwdriver. Back off the adjuster until the brake drag is eliminated.
