# Ford Fiesta

## Timing Belt Replacement

The featured vehicle in this article is a 2013 Ford Fiesta equipped with a 1.5-litre common rail diesel engine, an evolution of the older 1.6 TDCi. Developed in conjunction with PSA, this engine featured a reduction in piston diameter from 75 to 73.5 mm, an aluminium block with cast iron sleeves and an aluminium 8-valve cylinder head equipped with hydraulic tappets. This new diesel engine was later used in many other Ford models, including the B-Max, Courier, EcoSport, Focus, C-Max, Kuga and Mondeo.

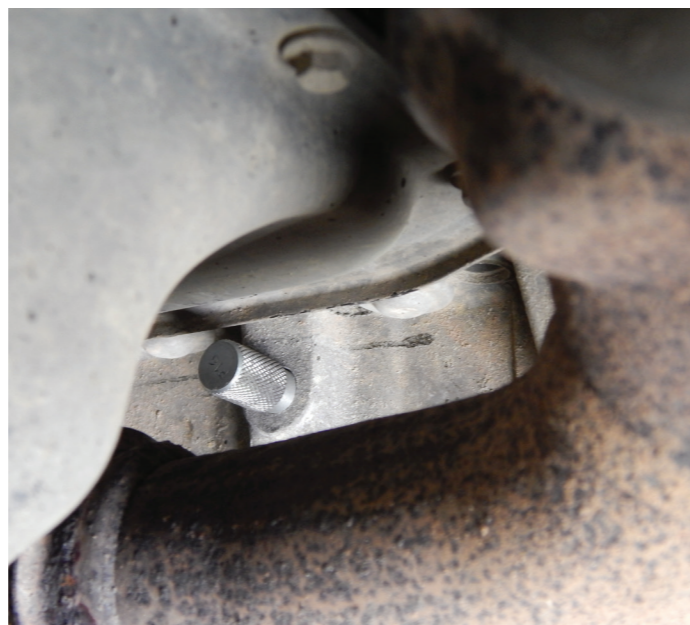
Figure 2

Rotate the crankshaft slowly in a clockwise direction, then insert the locking pin for the crankshaft, making sure it is fully inserted into the flywheel (Fig. 2).

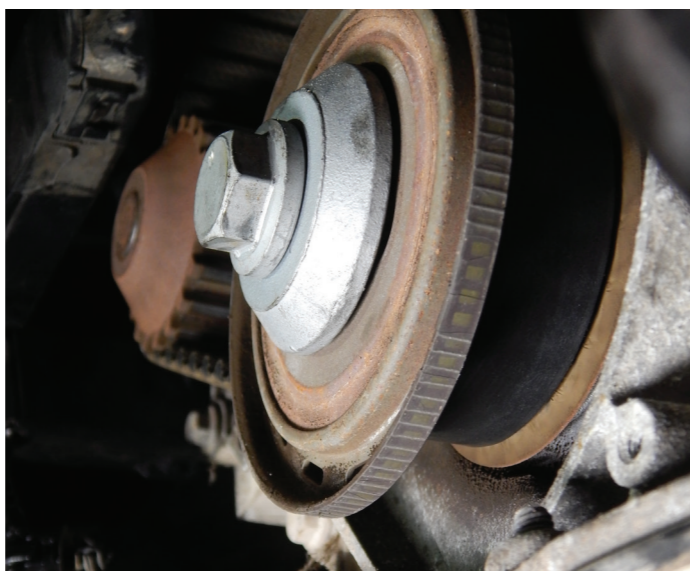
Figure 3

Then refit the retaining bolt to the crankshaft sprocket, taking extra care with the crankshaft position sensor ring.

**Note:** this part is extremely sensitive to any cleaning or handling and may become faulty, leading to an incorrect sensor signal. This results in an engine management malfunction with a crank sensor signal fault being logged as fault code P0336. It is advised that this component, which is part of the timing belt kit, be changed every time it is removed to save time and possible issues. (Fig.3)

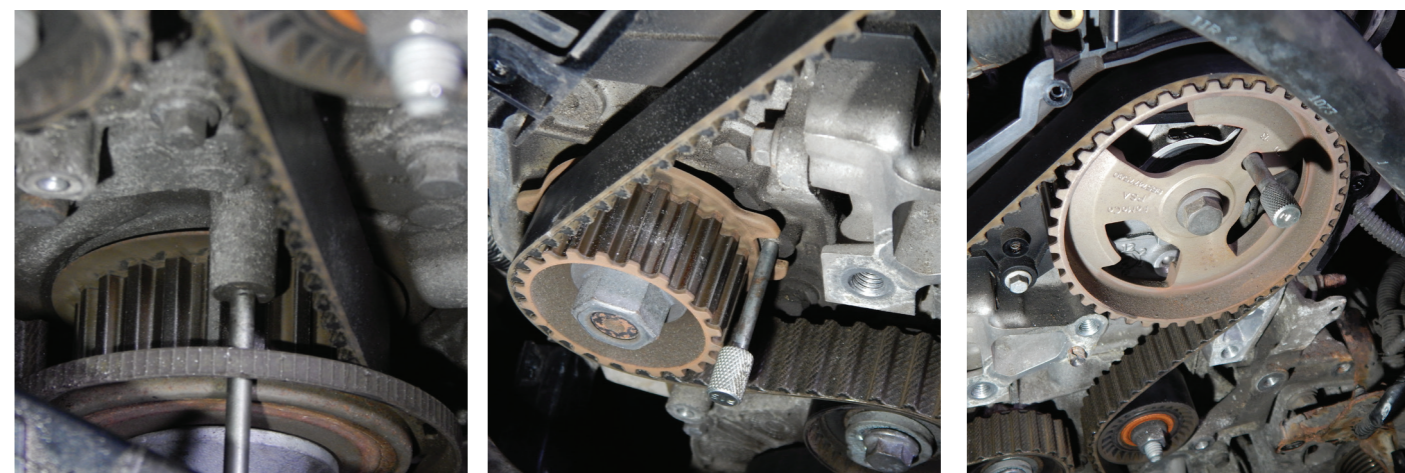
Figure 4

Next, remove the auxiliary belt tensioner and the lower timing belt cover, then rotate the crankshaft until piston No. 1 is at top dead centre (TDC). Install the timing pegs into the crankshaft, camshaft and injection pump. (Fig.4)

Temporarily refit the crankshaft bolt and tighten. Remove the timing pins and rotate the crankshaft slowly clockwise six times. Reinsert the timing pins and locking tool before rechecking the tensioner. If all timing pins align and the tensioner is set correctly, remove the crankshaft bolt and refit the lower timing belt cover and crankshaft sensor. Fit the TVD pulley and tighten the new stretch bolt to 35 Nm, then a further 190°.

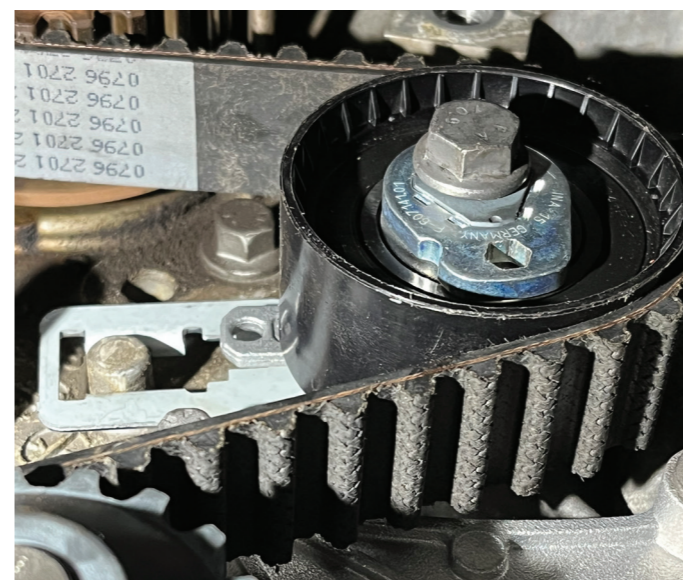
Figure 5

After ensuring all mating surfaces are clean, install the water pump - followed by the timing belt idler and tensioner pulleys. Lastly, fit the timing belt. To do so, first centre the key within the keyway of the crankshaft pulley, then fit the belt in a clockwise direction starting with the camshaft pulley. Using an Allen key, adjust the tensioner anti-clockwise until the pointer is in position (Fig. 5), then tighten the tensioner nut.
