NEW PRODUCT HIGHLIGHT | JAN2021

febi 108217

Button for tailgate

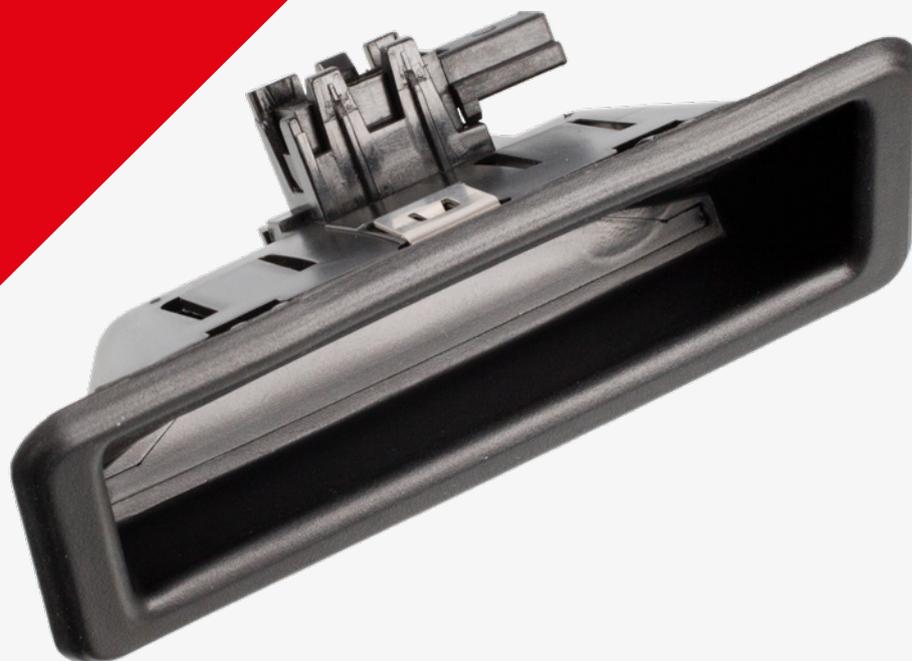
When the external tailgate/luggage compartment release switch is depressed, the switch completes the circuit. The tailgate release actuator then receives a release signal from the Body Control Module and the tailgate/luggage compartment is then able to be opened.
