NEW PRODUCT HIGHLIGHT | JAN2020

febi 109176

to fit:
Various Volkswagen, Audi, Seat and
Skoda models

Adjustment motor for recirculating air flap

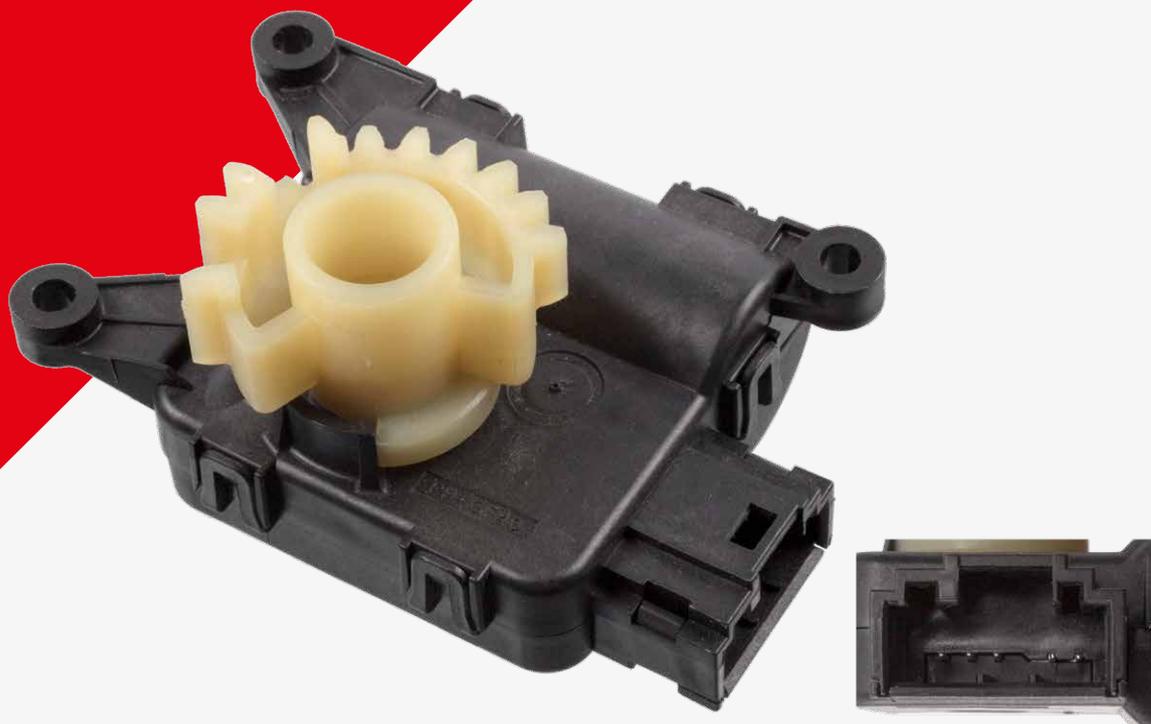
To operate the interior heater recirculating air flap, for the mixture of the air into the cabin, which is operated by the heater controls.

A clicking noise from behind the glovebox area, after the engine is started. This noise is from the heater recirculation air flap motor, due to a worn gear drive.
