# febi 47947 49370, 49560

Various Peugeot/Citroën/DS, Vauxhall/Opel and Toyota models fitted with the 1.2-litre three-cylinder engine

## Timing Belt

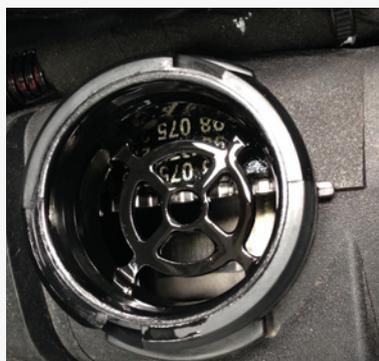
Figure 1

Premature deterioration of the timing belt material can lead to the loss of engine oil pressure and the oil pressure warning lamp showing as illuminated. In addition, fault codes P15A0, P15A1 and P15A8 will be present and logged in the engine control unit.

The 1.2-litre PSA group engine is fitted with a timing belt that runs in oil. In some cases the timing belt material deteriorates during service - leading to a blockage of the engine oil ways. This can cause severe engine damage and/or loss of vacuum assistance to the braking system.

It is important that the vehicle manufacturer's recommended service replacement intervals are regularly checked and adhered to for each model. These essential checks are important as changes have been made to the recommended replacement of the original timing belt during the production period of this engine (subject to make, model and assembly date range). In addition, the timing belt should be visually checked at each service along with the use of the recommended engine oil. (Fig. 1)

If the timing belt material is found to be deteriorating, and the above mentioned fault codes are present, then the engine will require a thorough inspection. The components that are sensitive to being affected are the: engine oil pump strainer, vacuum pump oil filter, variable timing solenoid valve filters and the camshaft bearing caps. Once you have established which parts have been affected (by the timing belt material blocking the oil ways) you should replace as necessary.
