Mercedes-Benz A-Class (W169) A150, A160, A180, A200. B-Class (W245) B150, B160, B170, B180, B200

M266-920, M266-940, M266-960, M266-980

## Tensioner, timing chain

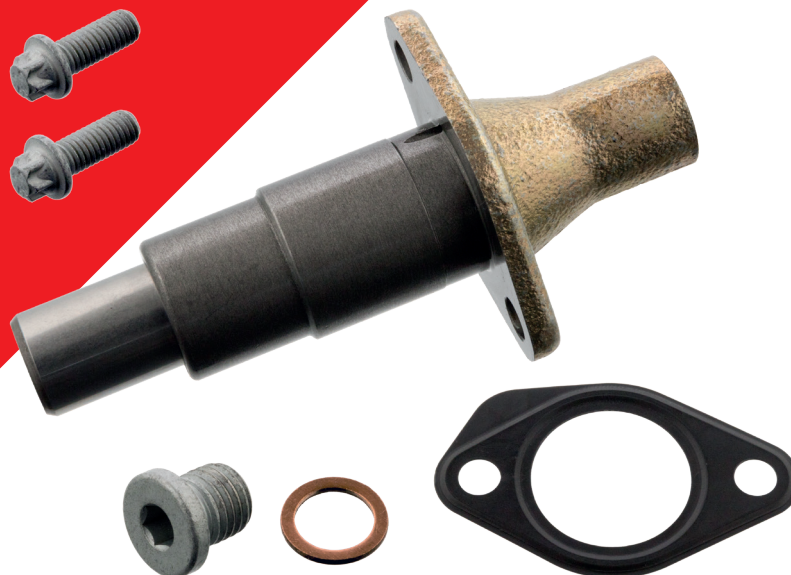
Over time the spring inside the tensioner wears, losing its tension. The rate of wear is increased if the vehicle is using incorrect engine oil as this leads to the build-up of carbon particles. This accumulation of particles restricts the flow of air into the tensioner and damages the seal of the piston, resulting in a loss of pressure/tension.

The timing chain tensioner is located on the right-hand side of the cylinder head, secured with 2 x M6 bolts.

Remove the bolts and the old tensioner assembly. Clean the gasket mating surface on the cylinder head and install the new tensioner using the bolts provided in the kit; tightening them to 8 Nm torque.

Replacing the tensioner assembly may reduce or eliminate the noise, however, febi recommends that the timing chain and guides are inspected and also replaced if necessary for a complete repair.

It is also recommended to fit a new engine oil filter and replace the oil with the correct type at the same time.
