febi 171968

To Fit:
various Citroën, DS, Fiat, Mitsubishi, Peugeot and Toyota models

Engine: 1.4 and 1.6 diesel

Air filter

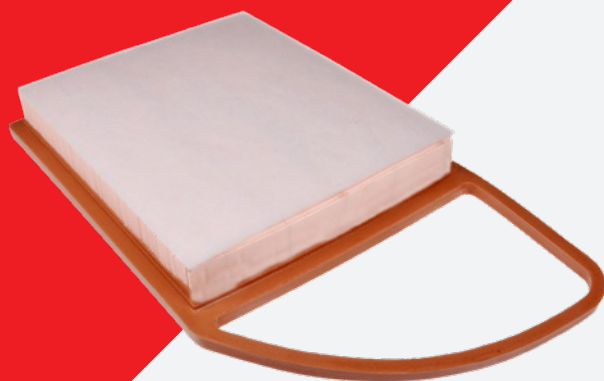
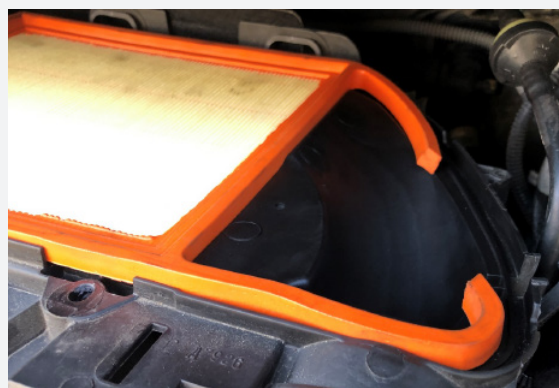
Figure.1

When replacing the air filter element in the vehicles listed above, care must be taken to make sure the foam seal of the filter element is installed correctly into the air filter housing. An incorrect installation can result in the foam seal being damaged or cut by the upper part of the filter housing during assembly. Damaged or cut parts of the seal can be ingested into the engine, resulting in engine damage. (Fig.1)

The foam seal loop of the air filter element, which seals the air intake section of the housing, can be distorted or misaligned during installation.
