# febi 21530, 27880

Mercedes-Benz CLS-Class (219),  
E-Class (211), SL-Class (230, 231)

## Control Arm Bush

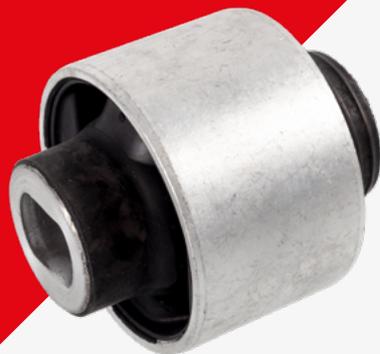
febi 21530 (old implementation)

If the original bush that is removed from the control arm is the early rubber metal design, febi recommends installing the improved hydraulic version. If this is the case, febi suggests replacing both control arm bushes at the same time to improve the vehicle's noise, vibration, and harshness characteristics.

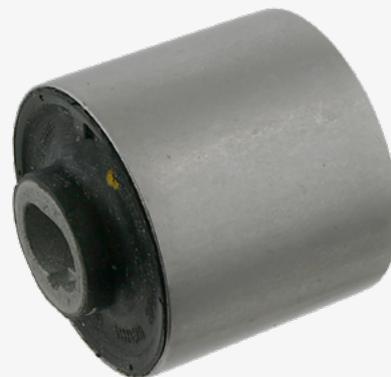
febi 27880 (new implementation)
