febi 23826,
100751, 102651, 171309,
171156, 171340, 171389,
178022, 100433, 100505

ABS Ring

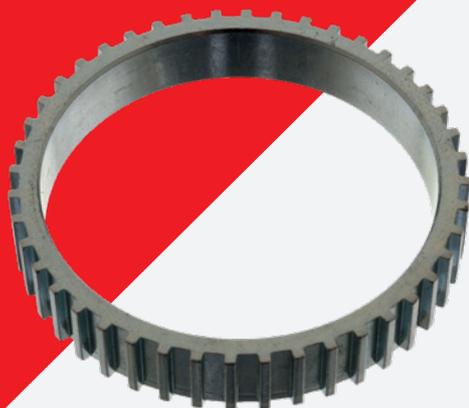
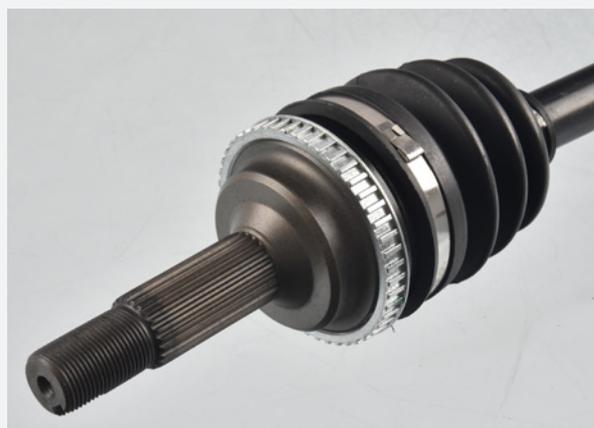
The anti-lock braking system (ABS) warning lamp is illuminated, wheel-speed sensor fault codes are present in the control units, there is a 'grinding' noise whilst driving, the brake pedal is 'pulsating' under light braking, and the cruise control is not working correctly.

There is excessive corrosion build-up on the driveshaft joint where the ABS ring is located, causing the ring to split. Alternatively, the ABS ring has become corroded or damaged. It is therefore giving an incorrect wheel speed reading.

Remove the affected driveshaft from the vehicle - as well as the ABS speed sensor if required.

Remove the broken or corroded ABS ring from the driveshaft joint by 'prizing' it off with a chisel or old screwdriver, taking care not to damage the surface of the driveshaft joint.

Clean the joint using steel wool or emery cloth to remove all corrosion from the mating surface.

Heat the new ABS ring to allow the metal to expand, then insert the new ABS ring onto the joint, ensuring it is seated correctly. Allow it to cool for a permanent fixing.

Inspect the ABS sensor for damage and replace as necessary.

Refit the repaired driveshaft to the vehicle and reset any fault codes caused by the faulty ABS ring with suitable diagnostic equipment.
