To Fit:
Ford Focus and C-Max Models

Wheel Bearing Kit with Wheel Hub and ABS Sensor Ring

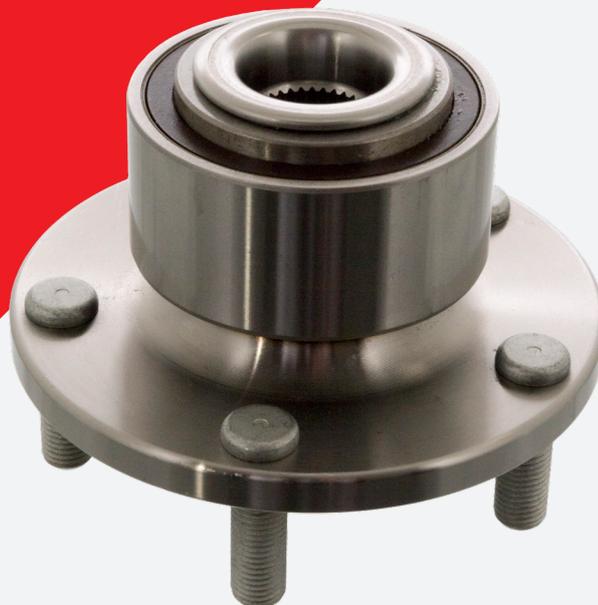
Anti-lock brake system (ABS) warning lamp is illuminated and the following fault codes are logged into the ABS module:

- C1141 front left wheel speed sensor/ring gear defective
- C1142 front right wheel speed sensor/ring gear defective

Loss of wheel speed signal to the ABS system due to excessive front wheel bearing movement and inadequate fitment of the bearing in the wheel knuckle assembly.

Replace the defective wheel bearing, ensuring that the mating surface in the wheel knuckle assembly is thoroughly clean and dry and is free from grease, debris, and corrosion. In order to prevent the bearing moving in the wheel knuckle bore when installing the new bearing, clean the contact surface and apply a thin film of sealant, such as a thread lock (26709 or 26710), to the mating surfaces of the bearing and wheel knuckle bore before pressing the new bearing into the knuckle.

After assembly, reset all fault codes and test to ensure for the correct operation of the brake system.
