febi 32418, 103186

Ford, Mazda, and Volvo various models

Control Arm Bush

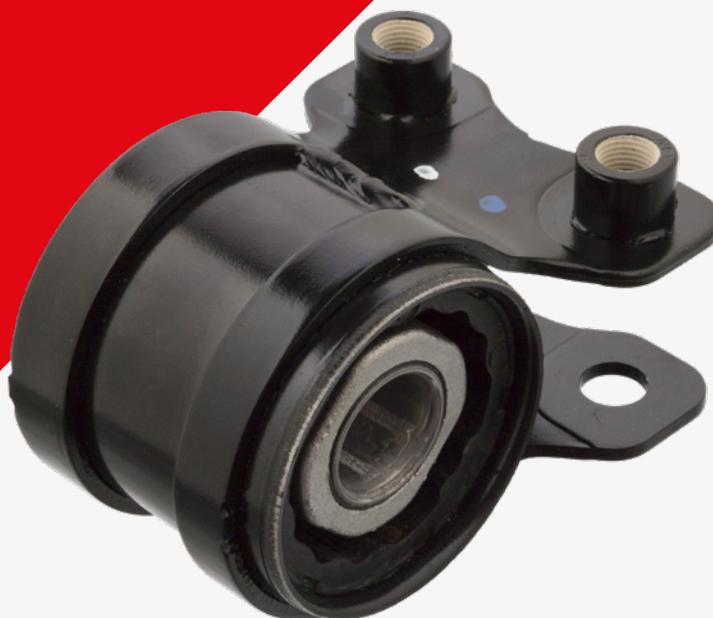
Uneven tyre wear and misaligned front suspension.

Worn lower suspension control arm control bush.

febi provides an economical repair solution; the control arm bush can be replaced rather than needing to replace the entire suspension control arm. When replacing this bush, it is important that the alignment of the original control arm bush is followed. If the bush is not aligned correctly on the shaft of the suspension arm, there is a risk of premature failure and a shortened lifetime of the component.

There is a special tool available from the vehicle manufacturer to assist in the replacement of the control arm bush.

By using this tool, it can be ensured that the installation position and press-fit depth of the bush will be correct.
