# TECHNICAL REPORT

Assembly of the gasket with  
Ajusa part number 01887100

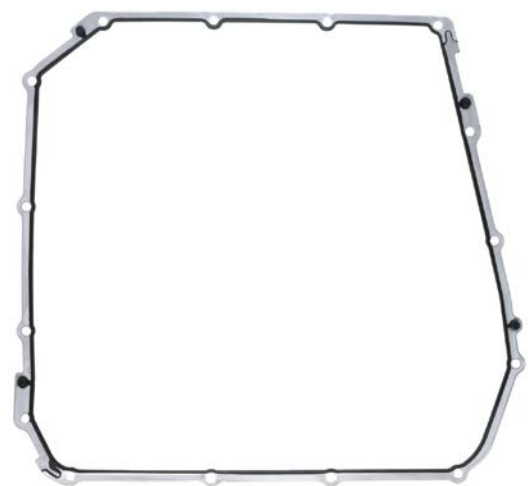
SEE PART NUMBER

**Part number 01887100** is designed to replace the OEM gaskets OB5321371E and OB5321371F, fitted to OB5 gearboxes from the VAG Group, also known as DL501. This automatic transmission features a longitudinally mounted wet dual-clutch unit, delivering power to the wheels quickly, efficiently and comfortably.

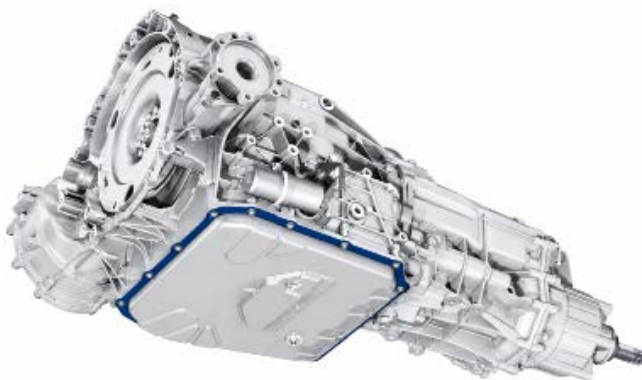
Position of 01887100 on gearbox

This circuit has a lower sump, sealed by gasket 01887100. It features an external oil filter and an internal suction filter. It is equipped with active cooling.

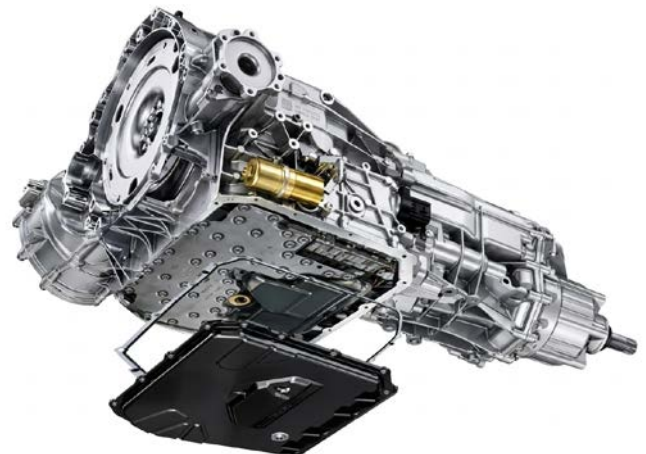
Expanded view of the ATF housing

As can be seen in the image, 0B5 gearboxes use **two separate types of oil**, each requiring specific fluids and maintenance procedures.

**1. Mechatronics and clutch control circuit:** This consists of a circuit covered with ATF (specific to the manufacturer/model).

**2. Gear and differential lubrication system:** immersed in a manufacturer-specified oil, it lubricates the moving parts. It does not have a dedicated sump, nor does it feature a filter or forced cooling.

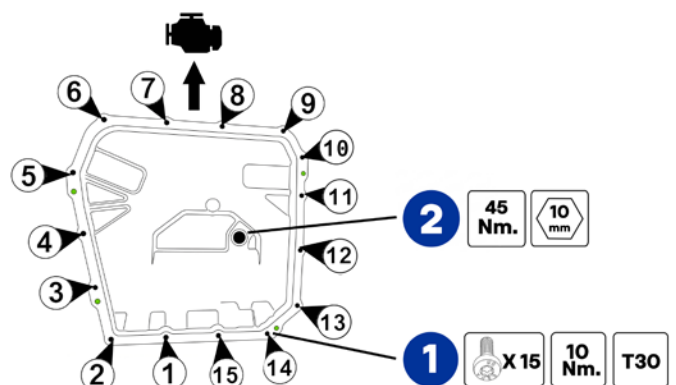
**3. Tightening:** then tighten the 15 bolts in the order shown in the diagram to 10 Nm.

**4. Replace the washer** that comes with the drain plug. Tighten to 45 Nm
