Technical Bulletin

TCK119 & TCK323 - Read Before Installation

TB0033

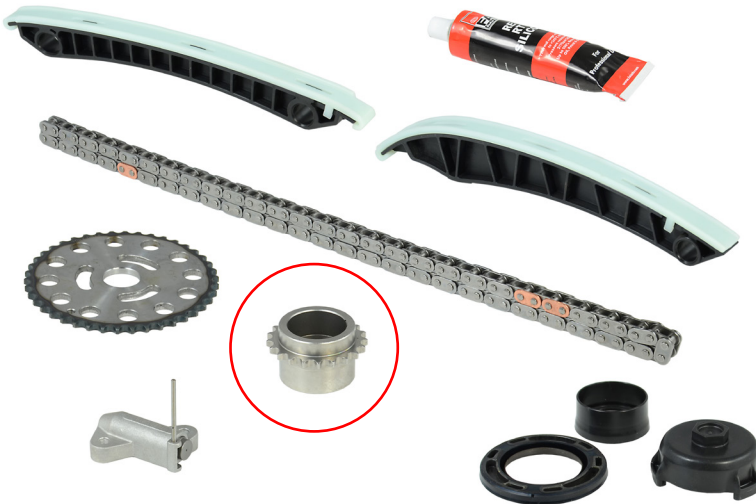
Please check crankshaft sprocket being removed matches the sprocket in this kit.

TCK119
38mm
Sprocket

TCK323
33mm
Sprocket

If the wrong crankshaft sprocket is fitted, the crankshaft pulley will be out of alignment preventing fitment of auxiliary drive belt(s).
