Service Info

Coolant pump 538 0314 10

Failure due to additional sealant being applied

Issued 07.2017 INA 0167 Technical content subject to change
 OE Manufacturer's names and numbers are used for reference purposes only
 © 2017 Schaeffler Automotive Aftermarket GmbH & Co. KG

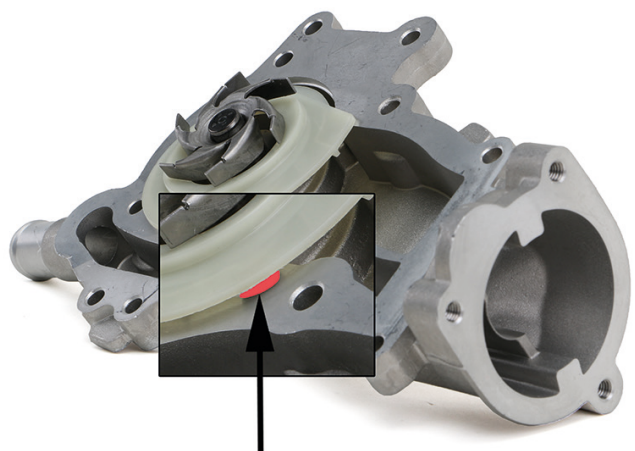
Fig. 2: Distorted plastic shield due to excess sealant

If additional sealant is used during installation, excess sealant is forced between the coolant housing, and the plastic shield that guides the coolant flow (Fig.2), causing it to distort. In operation the shield is forced against the impeller, damaging or completely destroying the shield, which results in coolant pump failure. Fragments of the plastic shield are passed through the cooling system, and can cause consequential damage.

Coolant pump 538 0314 10 is sealed with a gasket. NO additional sealant may be used during installation.

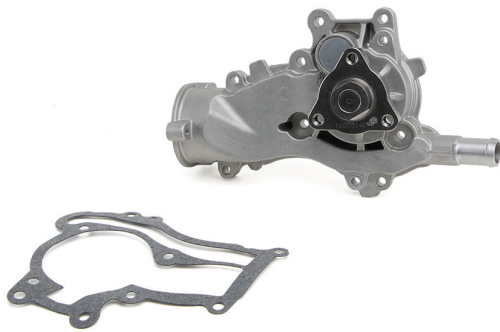
Fig. 1: 538 0314 10 - Coolant pump with accompanying gasket
