Service Info

Installing coolant pumps correctly

Installation without additional sealant

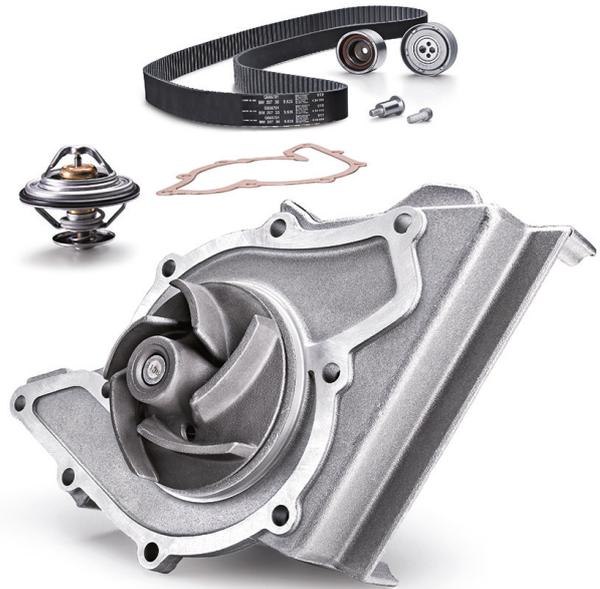
Fig. 2: Coolant pump KIT with paper gasket

When a coolant pump shaft is sealed with a flat gasket or an O-ring seal, NO additional sealant should be applied during installation.

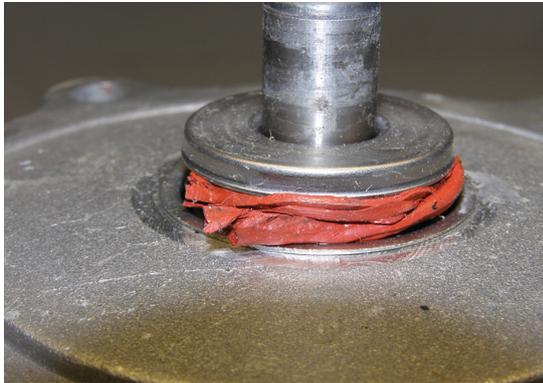
If additional sealant is applied it forms a bead on the inner section of the casting, this is removed with the coolant flow, and becomes wrapped around the rotating pump shaft between the housing, and the impeller. The coolant pressure, forces the sealant residue into the rotating mechanical seal (Fig.1) and causes component failure.

Fig. 1: Hardened sealant on pump shaft between housing and impeller (disassembled)

Before mounting a new coolant pump, use a scraper or a soft scouring pad to prepare and clean the seal surfaces.
