## INA Service Info

# Chain drive: metallic noise

## Broken plastic rail of the lower timing chain guide

Models: ASTRA J, INSIGNIA A / B, MERIVA B,  
MOKKA, ZAFIRA TOURER C

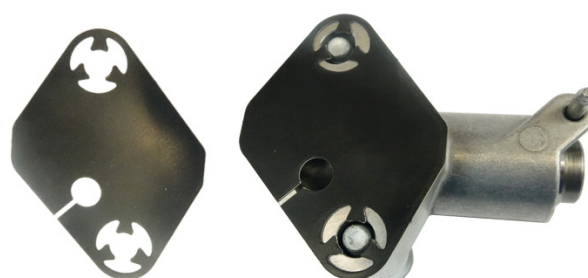
Image 2: Gasket between the engine block and the chain tensioner

In both cases, the problem can be attributed to low oil pressure in the timing chain system. There is a new version of the tensioner that prevents the oil contained in the chain tensioners pre-filled chamber from returning to the engine oil sump during periods of vehicle downtime. This is made possible by using a very thin gasket that, due to its design, ensures that the correct amount of oil is always present in the pre-filled chamber of the tensioner (Image 2).

The timing chain tensioner, together with the new gasket, prevents the occurrence of vibrations generated by incorrect tension of the timing chain, thus avoiding excessive stress on the chain guide and preventing their breakage. This gasket can be found in the INA repair kits listed above. Check the online catalog for details.

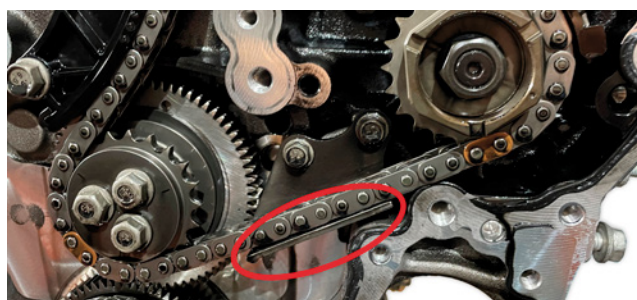
- Metallic noises coming from the timing chain at engine start-up;
- The need for replacement of the chain kit caused by the breakage of the chain guide (Image 1).

Image 1: Breakage of the chain guide

- In case of component breakage, additionally check for the presence plastic fragments in the engine oil sump, the oil pump, the oil filter and clean the system and replace components if necessary;
- If the oil warning light comes on at high mileages, check the condition of the oil pump, the oil filter and replace it if necessary;
- During kit replacement, we invite you to follow the instructions about INA Service Info 0178 for optimal chain lubrication.
