Piston Pin circlip failures

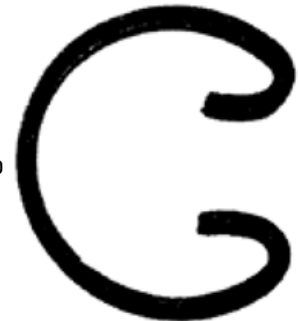
Fig. 2 - Rectangular

Rectangular circlip

The most common cause of failure of all three is due to over-stress when fitting. Only compress a circlip just enough to slip into the piston pin boss. Never butt the ends, as this will overstress the circlip causing cracking or loss of tension.

Never twist a circlip when fitting. The circlip must enter the pin bore groove squarely and be under sufficient tension when fitted to prevent finger pressure rotation.

Install the circlip with the open end of the circlip towards the bottom of the piston. Never position the open end to either side of the vertical axis under any circumstance. During operation the reciprocating forces could compress the clip dislodging the ends to from the groove.

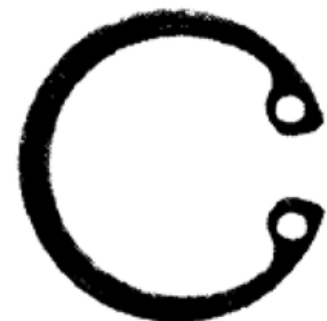
Fig. 3 - Seeger type circlip

Seeger type circlip

Always use circlip pliers of the correct type, particularly when fitting the Seeger type of circlips. Most Seeger type circlips have metric sized holes for the pliers.
