NEW PRODUCT HIGHLIGHT | JULY 2020

Blue Print ADBP330000

Various Citroen, DS, Fiat, Lancia
and Peugeot models

GUIDE SLEEVE FOR CLUTCH

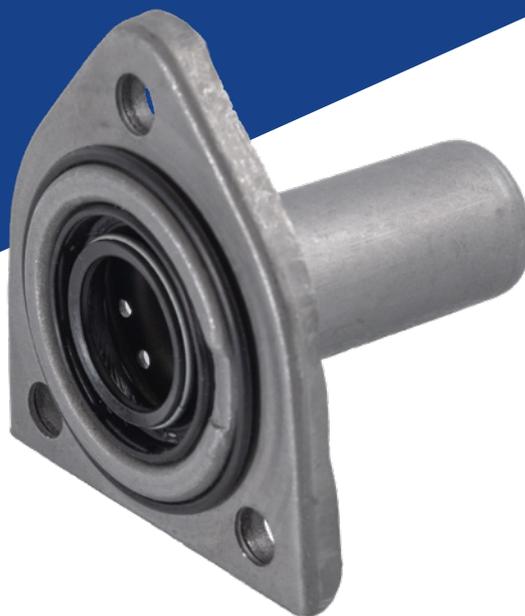
The clutch release bearing slides smoothly along its length, allowing the clutch to engage or disengage. It is built into the gearbox and houses an oil seal to protect the clutch assembly from the ingress of transmission oil.

Wear can occur over time on the guide shaft as a result of prolonged engaging and/or disengaging of the clutch. This can be accelerated if an incorrect lubricant was used during a clutch replacement. In addition, excessive build-up of dust and debris restricts the smoothness of operation which can also lead to wear.

Reusing a worn guide tube can cause clutch engagement and/or disengagement difficulties. The oil seal can become contaminated with generated dust as the clutch wears. If the seal fails, the gearbox oil can cause the clutch to slip. It is recommended that the guide sleeve be checked for wear and replaced as necessary when the transmission is removed for any repair work or clutch replacement.
