Blue Print ADM55390, ADBP530000

To fit:
Mazda 3 I & II, Mazda 5 I & II

Brake Hose

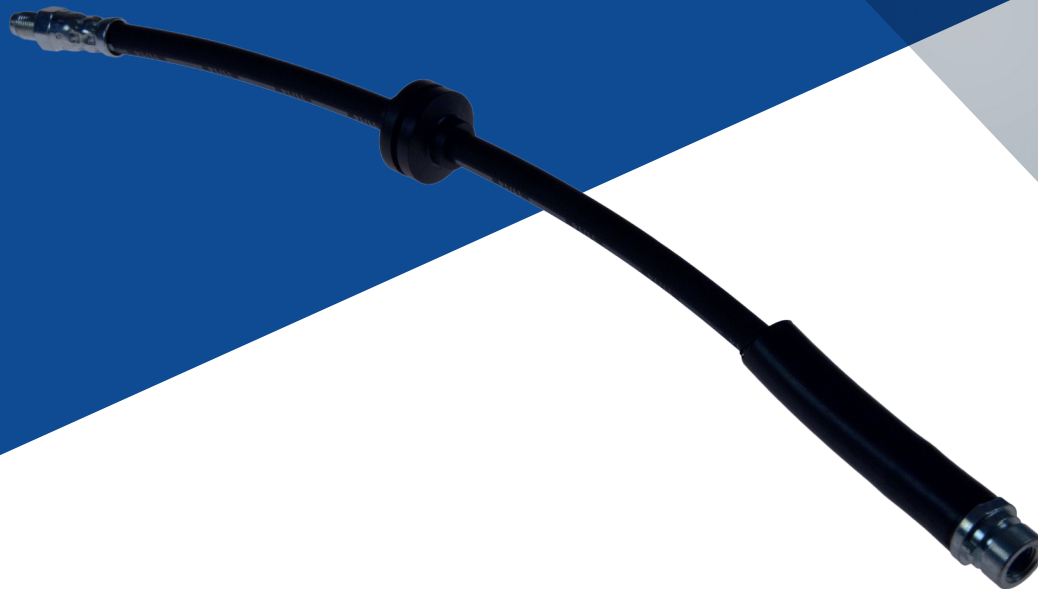
The brake warning light in the instrument cluster stays illuminated when the handbrake is released, and the brake pedal feels soft. The fluid level in the master cylinder is below the minimum line, and an external examination under the vehicle reveals a pool of fluid on the ground by either of the rear wheels.

The rear flexible brake hose is prone to corrosion where it joins the brake pipe. This hose has a rubber protective sleeve that provides it extra support, but this sleeve also traps moisture and debris from the road, causing the metal components within to corrode. This then compromises the connection, leading to a potential failure occurring when the brakes are applied, especially in an emergency situation.

The brake systems on the above models should be inspected regularly, and if any of the hoses are showing signs of corrosion affecting the metal unions they should be replaced as a matter of urgency.

Blue Print recommends replacing the brake fluid as part of this repair.
