Blue Print ADBP750045, ADBP730146, ADBP730147

To fit: Mazda 3 (BL) 08-14, 6 (GH) 07-13 and
CX-7 (ER) 06-14 equipped with the 2.2 CiTD diesel engine

Timing Chain Kit

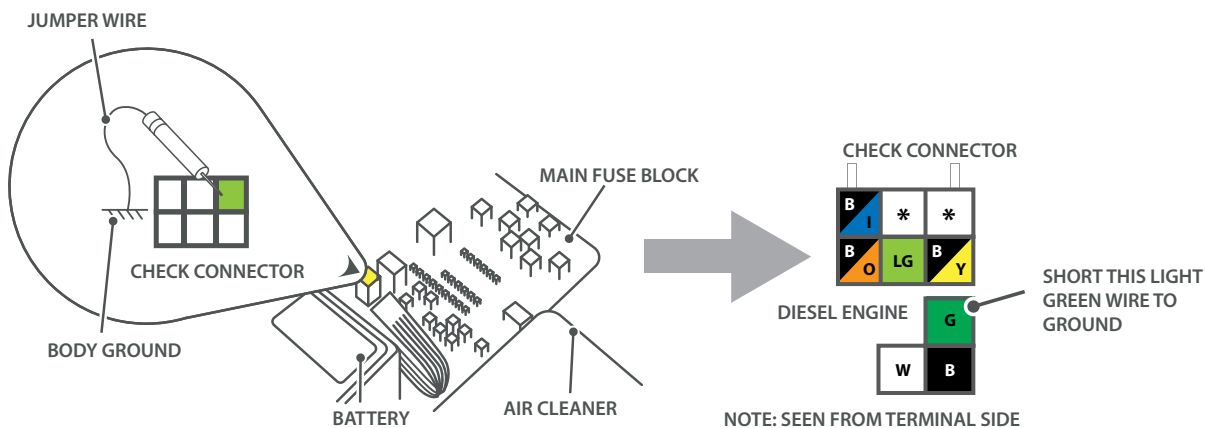
Mazda 6 (GH)

Short the connection between the terminals of the check connectors terminal using a jumper wire as per diagrams below for each model.

Start the engine and let it idle.

Depress and release the brake and clutch pedals fully at the same time.

Repeat this five times within five seconds.

Glow indicator light illuminates during initialisation.

Glow indicator light flashes five times when initialisation is completed.
