Blue Print ADG030148, ADG030149, ADG030150

to fit:
BMW MINI 1.4DT/1.6i 2001>2006i

BMW MINI CLUTCH KIT REPLACEMENT

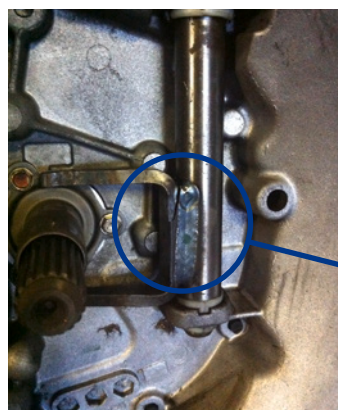
We have found that the cause of the problem can lie with a fracture in the weld of the clutch fork, allowing the fork to flex during operation which prevents the clutch from fully engaging. The symptoms are a dragging clutch, difficult gear selection and clutch judder.

CLUTCH FORK FRACTURE

It is imperative that the clutch fork is cleaned and thoroughly checked for fatigue/damage during normal clutch replacement. Good practice would be to recommend fitting a new fork at the same time as the clutch, as fork failure is a known issue with the MINI. With a repair time of 6.5 hours, this is one job that you wouldn't want to do twice on the same vehicle.

Blue Print also recommends that the fork pivot bushes and locking pin are renewed at the same time.
