Blue Print ADG08645

Hyundai Coupe all models 2001 > Sept 2004

Left hand lower suspension arm modification

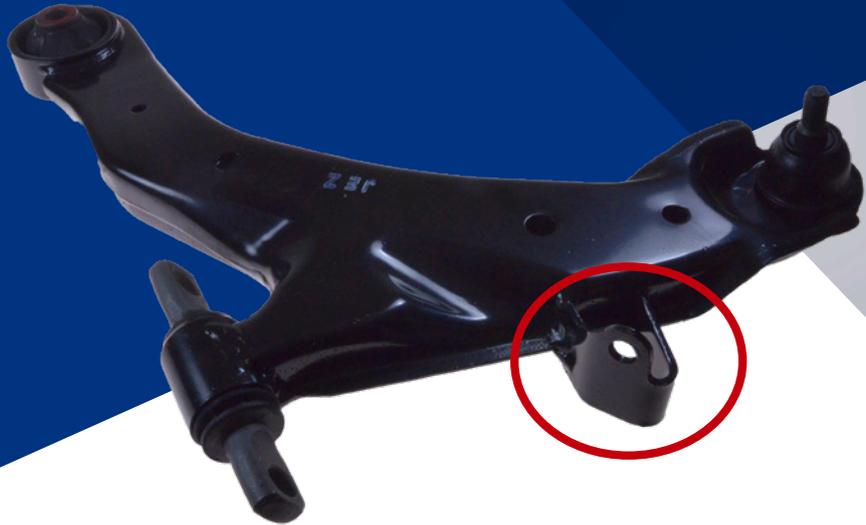
Blue Print follows the same OEM supersession as Hyundai (OEM) on the left front lower suspension arm supplied for the Hyundai Coupe. The arm is fitted with an anti-roll bar bracket which, on the Hyundai Coupe, is not required. Unless this is removed it can interfere with the operation of the suspension. The same situation arises with the original equipment component. This bracket must be removed before the arm is fitted to the vehicle.
