# Blue Print ADJ131301

Land Rover Freelander 1 1.8i, 2.0DT, 2.0DT - TD4, 2.5i - V6,  
1996>2006, Chassis Ref: LN

## Land Rover Freelander 1 – Tailgate Window Regulator Calibration

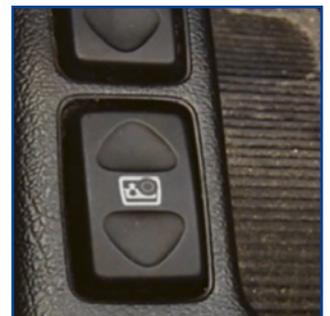
The tailgate window switch is located in the centre console near the handbrake.
