Blue Print ADW190101

ADW190101

Oil Drain Plug with O-Ring

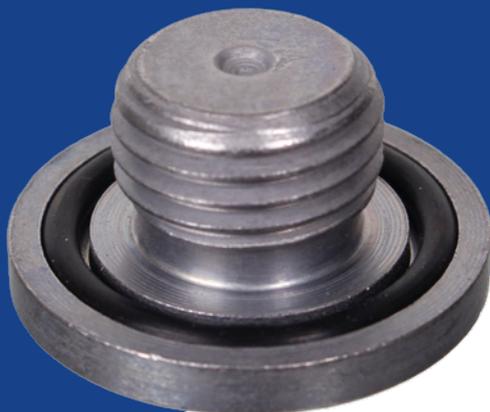
Original part Figure 1

The original oil drain plug fractures between the thread and the head of the plug (Fig 1) which poses a high risk of coming loose from the oil pan. This causes oil to drain from the engine, which can lead to engine failure as well as excess oil being spilled onto the road surface – a hazard to other road users.

The repeated loosening and tightening of the same oil drain plug, during routine maintenance, leads to the weakening of the drain plug material. This can be accelerated if the drain plug is overly tightened.

To avoid failure, Blue Print recommends that this drain plug is replaced during every oil change and tightened to the vehicle manufacturer's recommended torque settings.
