Engine:

Nissan - YD22DDTi; YD25 DDTi

BGA recommend when fitting TC0290FK; TC6320FK; TC6321FK; TC6322FK; TC6323FK:

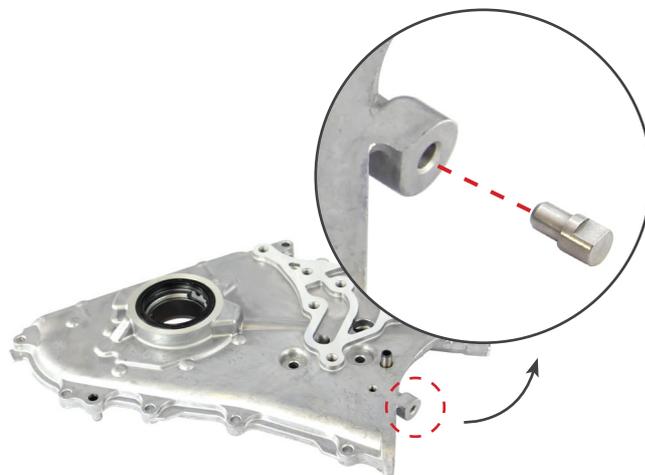
Image 1. LP6300

Ensure during fitment the jet faces towards the timing chain (inwards to engine block). Please see image 1 and image 2.

OE Number 13081-AD210 - for LP6300

The oil gallery is open until capped by the oil spray jet. Failure to fit either of these parts will cause low oil pressure and could affect the operation of the timing chain tensioner potentially causing catastrophic engine failure.

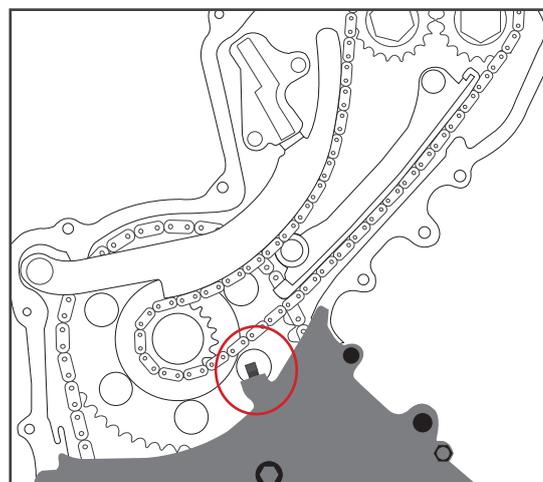
Image 3. Location reference when fitted.

Check the condition of the oil spray jet fitted to the oil pump (Image 3) and change it if required (See below OE part numbers).
