VB-3491 / VB-3832 VALVE BLOCK AIR LINE DIAGRAM

'12-'18 AUDI A6 / '13-'18 S6 / '14-'18 RS7 (C7)
'11-'18 A8 / '13-'18 S8 (D4) / '13-'18 S7 (C6)

VALVE BLOCK - AIR LINE DIAGRAM

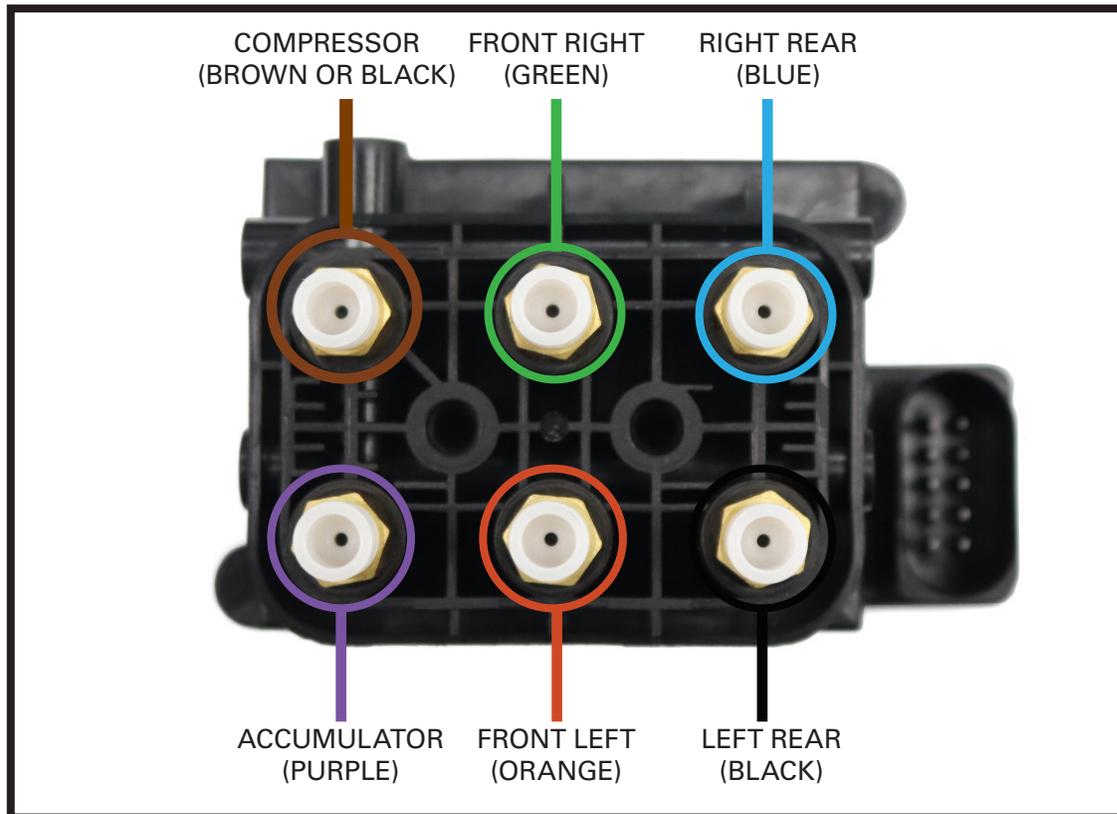
FIGURE 1

1. AIR LINE DIAGRAM. (FIGURE 1)
