VW steering lock

Invoking the locking mechanism without an inserted lock cylinder results in permanent locking

Steering lock for	VW, Seat, Skoda & Audi
OE Ref. No.:	1K0 905 851B
AIC Item No.:	56270

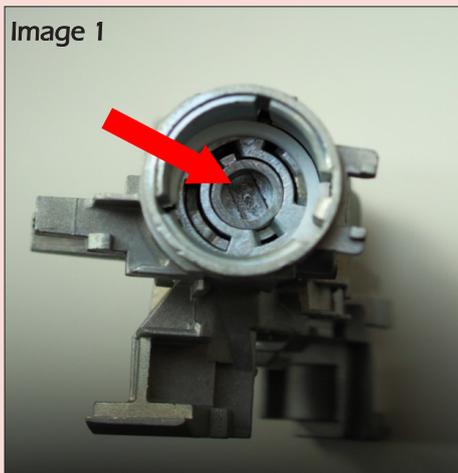
Doing something that is common practice when exchanging steering wheel locks will lead to lock 1K0 905 851B being rendered useless: due to its construction attributes, testing the lock by pressing the locking mechanism (image 1) without an inserted lock cylinder will cause the bolt to close (image 2) and jam the lock permanently. The part can then be no longer deployed.

If you wish to test the lock prior to installation, ensure that you first insert a lock cylinder.

The permanent jamming of the lock occurs due to its specific construction attributes. The locks can also not be reopened by AIC. Locks that are jammed in this manner and rendered useless cannot be accepted as a guarantee claim.
