Exhaust gas recirculation (EGR) valve prematurely defective?

## The causes for premature failure of a new EGR valve can be many and varied!

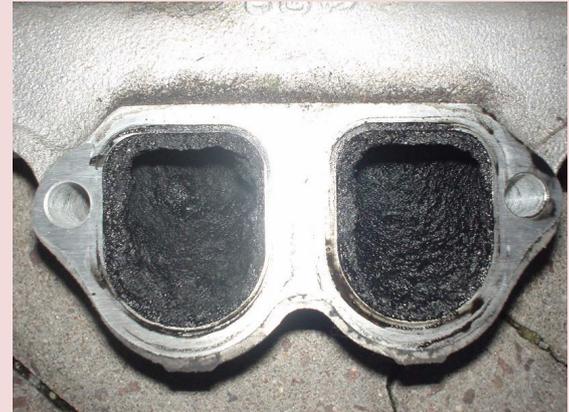
- A fault in the motor management system or incorrect software version
- Frequent short-distance operation
- Frequent driving in the partial load range (EGR control range)
- Unclean combustion, e.g. due to defective injectors or leaky boost pressure system
- Oily intake air due to worn-out valve stem seals, faulty engine ventilation, loss of oil in the cylinder head or turbo charger area, worn-out piston rings, overfilled oil or extreme engine wear (blow-by gases in the crankcase) resulting in a high carbon content in the exhaust (carbonisation) and soot formation.

**If the actual cause of the problem is not found and rectified when exchanging the defective EGR valve (e.g. the sooting up of the exhaust manifold), the newly replaced valve will also not last long.**

It is essential to assess the level of cleanliness of the exhaust manifold prior to installing the new EGR valve. If necessary, the manifold may need to be removed and cleaned to ensure residual deposits do not subsequently come loose and enter the new EGR valve. New seals are to be used for installation, too.
