### Causes of wear of the cylinder head cover

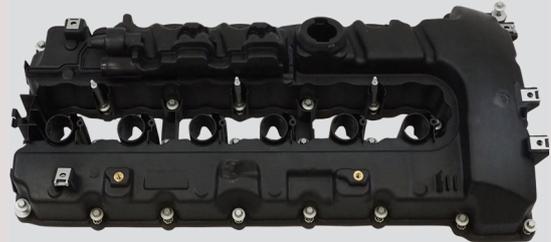
AIC item no.: 57251  
OE ref. no.: 1112 7 565 284

The following things could be related to a defective cylinder head cover:

- the vehicle leaks oil
- oil smell in running condition
- engine runs unevenly

To blame for the above-mentioned anomalies are usually:

- a leaky seal
- clogged valves for crankcase ventilation
- tearing of the cylinder head cover receptacles due to aging or incorrect assembly

If you notice any of the above damage to the cylinder head cover, do not hesitate to replace it with a new one. In most cases, the repair of the hood also includes the replacement of the seals. If these signs are ignored, the vehicle may even suffer engine damage in extreme cases.
