Liner flange cracking

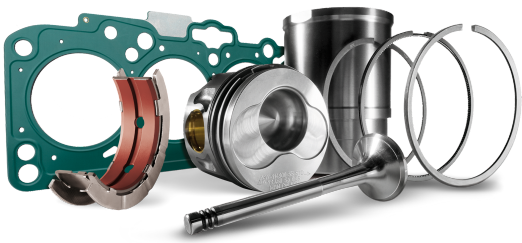
Cracks that start under a liner flange form when the flange flexes and pulls the liner material apart.

The causes of this type of fault are:

- The cylinder block recess out of square (Fig. A)
- Dirt trapped between the flange and its recess (Fig. B)
- Incorrect location of the cylinder head gasket or using the wrong gasket (Fig. C)
- Leaving a sharp corner or burrs of machining on the cylinder block (Fig. D)

Faults (Fig A, B, C & D) form cracks when tightening the cylinder head and forcing the gasket down on the liner flange.

Cracks lengthways down the cylinder liner occur when fitting the liner in the cylinder block or when fitting the cylinder head. Careful handling and storage helps to prevent these cracks forming.
