Teeth are sheared off the timing belt during the starting process or after a short mileage. CT1140K2 and CT1140WP2.

Various diesel engines Euro 6: Opel 2.0; Citroen/ Peugeot 2.0/ 2.2 Blue HDi; Ford 2.0 TDCi / ECO netic / ECOBlue; Toyota 2.0 D4d

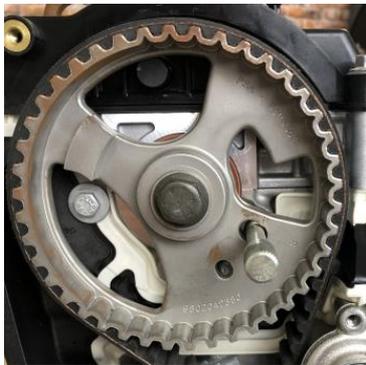
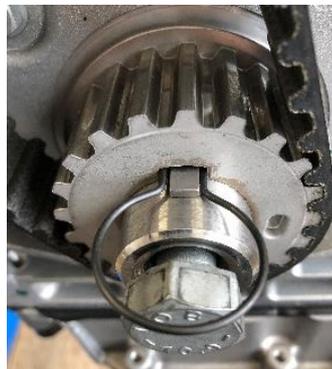
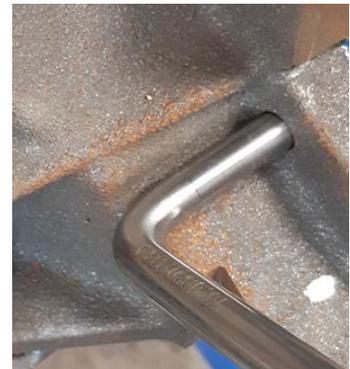
Teeth are sheared off during the starting process or after a short running time, possibly engine damage.

The belt drive is equipped with an oval crankshaft sprocket to reduce power peaks in the belt drive. The crankshaft sprocket is mounted loosely/ movably on the shaft and can be twisted without using the special tool. This, in combination with an incorrectly mounted high-pressure pump, leads to greatly increased force peaks and can cause the timing belt to fail.

If the high-pressure fuel pump was removed and installed in addition to the timing belt replacement, it is essential to ensure the correct installation sequence! First fit the timing belt completely and then the high-pressure pump. The tensioning process must be carried out according to the vehicle manufacturer's instructions, using all the special tools intended for this purpose.

When installing the tensioning pulley, make sure that it is seated on the pin and that the tensioning pulley lock is not removed until the timing belt has been installed. The tensioner pulley must be overtensioned in the first instance and the engine spun 4 times before the final tension is set. (see installation instructions of the respective vehicle manufacturer).
