# SWAG 40 93 3044

to fit:  
Opel 2.0l turbo and 2.2l petrol engines

## Chain tensioner

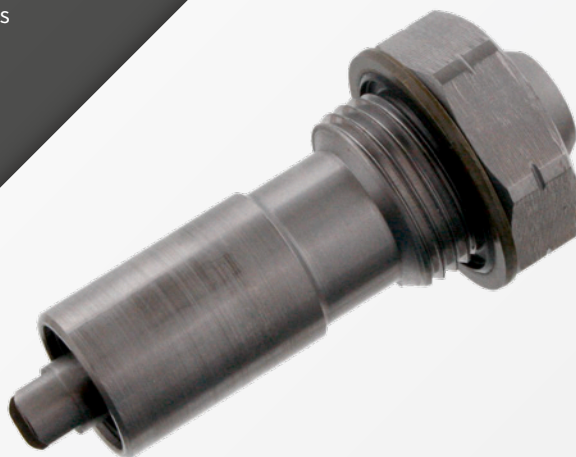
Although all the components have been correctly fitted, rattling noises are often present (caused by the elongation of the timing chain). If the timing chain slips as a result, then the engine can run erratically and misfire and in the worst case cause extensive engine damage. This affects Z22YH and Z22SE engines.

A blocked timing chain tensioner. The original version (repl. no. 0636549) of the chain tensioner had a green O-ring and a rubber-lined washer (see Fig. 1). The vehicle manufacturer fitted this version in the engines mentioned above. A modified chain tensioner has been used in production since model year 2009.

SWAG recommends using only the new chain tensioner SWAG 40 93 3044 (repl. no. 4807 839). This is provided with a rubber-lined metal washer under the head (see Fig. 2). This ensures perfect guidance of the timing chain.

We always recommend that a new timing chain (SWAG 40 93 3043 repl. no. 5636 396) is fitted when replacing the chain tensioner. Both components are included in the chain kits SWAG 99 13 3042 (fits Z22YH) and SWAG 99 13 3045 (fits Z22SE)!

To prevent the timing chain from skipping when the engine is running, the chain tensioner should not be brought into the working position until the chain has been fitted. Please refer to the attached Info for details.
