SWAG 30 92 1764

to fit:
 Seat Cordoba,
 Seat Ibiza II, III (1.4 16V AFH, 1.0 16V AVZ)
 VW Polo 3 (1.4 16V AFH)

Repl. no. 036 109 243 J

Timing belt tensioner

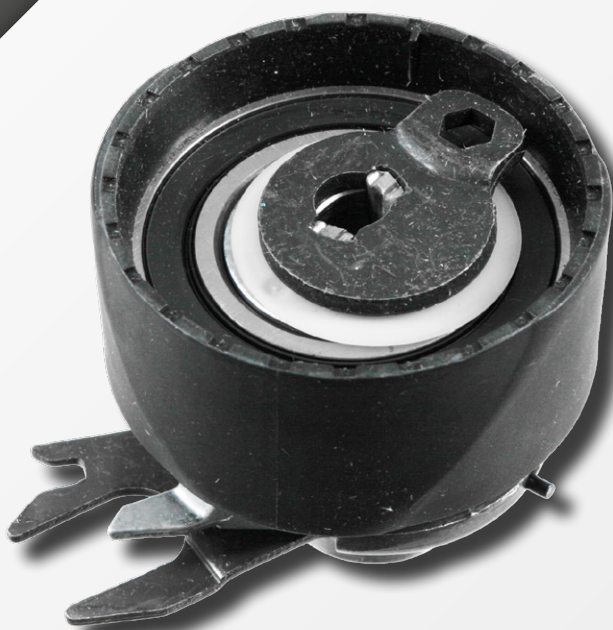
The belt tensioner causes timing belt vibrations which leads to noise.

The original version of the timing belt tensioner (repl. no. 036 109 243 D and 036 109 243 G) is round in shape. The round shape leads to the timing belt vibrations and noise described. This version has been replaced at VW and is no longer in use.

This noise-optimised belt tensioner has been developed specially for the applications outlined above. The running surface of the belt tensioner has diagonal elevations (see photos). It is deliberately like this to ensure that the timing belt runs more smoothly. The uneven running surface reduces vibration of the timing belt. At the same time, it also means a longer service life for the timing belt.

The running surface of the tension roller with diagonal elevations is not a production fault! The tightening torque of the tension roller screw is 20 Nm.

SWAG recommends using timing belt tensioner SWAG 30 92 1764 (repl. no. 036 109 243 J).
