Loss of Direction

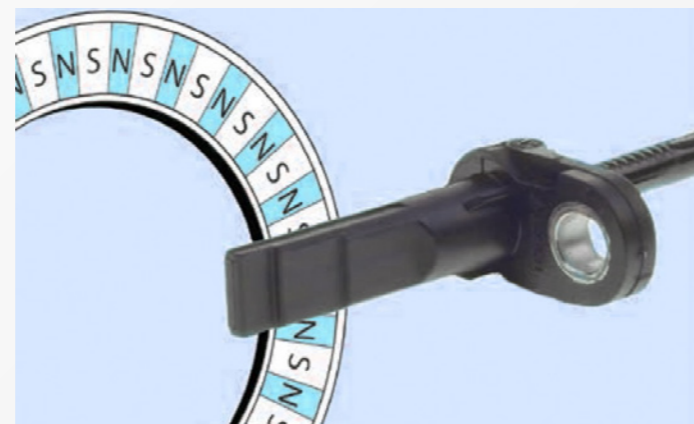
Figure 2

The wheel speed sensor is mounted in the hub at right angles to the magnetised impulse reluctor ring, which is mounted on the wheel bearing assembly. The active wheel speed sensor makes use of the magnetic resistive effect; a magnet in the sensor produces a magnetic field with the lines of magnetic flux running at right angles to the sensor layer. Deflection of the lines by the impulse wheel causes changes in resistance in the thin ferromagnetic layer of the sensor element. (Fig.2)

The sensor element converts the changes in resistance into voltages. The square wave voltage detected by the brake control unit is a measurement of individual wheel speed which is used to derive the acceleration and deceleration of wheel speed and is definitive for brake control.
