Various Volkswagen, Audi, SEAT and Škoda models.

Oil Filter

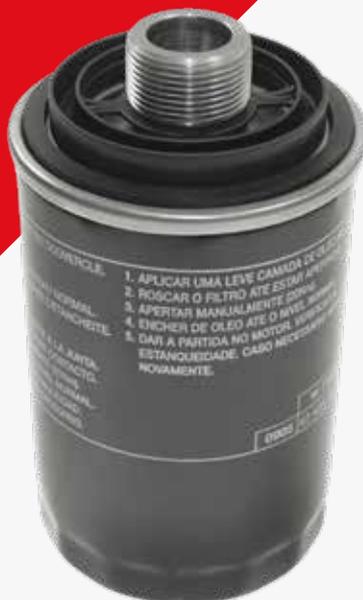
Insufficient engine oil pressure; oil pressure warning lamp is illuminated after the engine oil and filter have been replaced.

Upon removing the old oil filter, a spring-loaded polyamide spigot valve - inside the housing - is released. When the valve moves upwards, it opens a passage for the oil accumulated in the housing to return to the sump. The installation of a new oil filter loads the spring and closes the drainage channel, ensuring that the engine oil flows through the filter during operation.

Problems can arise if the valve becomes stuck in the lower position after removing the old oil filter, which is usually indicated by the presence of 'old' oil in the housing. The spring will still be sprung-loaded and the valve can release ('spring' out) at any time. If the new oil filter is installed without the valve, the engine oil flows directly back into the sump after starting the engine. Consequently, the engine cannot reach the sufficient oil pressure - which then illuminates the oil pressure warning lamp.

Before installing the new oil filter, ensure the polyamide spigot valve is installed in the housing. If the valve is missing (having 'sprung' out as explained previously), find and clean the original valve, lubricate the 'O' ring-seals, and re-insert it into the housing. Alternatively, you can install a new valve - before installing the new oil filter. (Part No. 06J 115 679 E)
