124

TECHNICAL REPORT

Ajulock (75000500) thread
locker on flywheel bolts

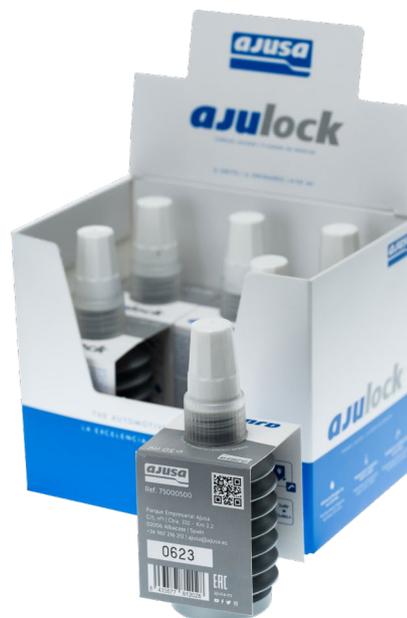
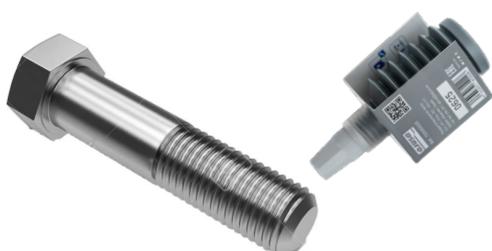
As it not only serves to retain the screws, but also **prevents oil leakage** through the threads themselves, since in some crankshafts the screw threads are not blind, but through, they are in contact with oil from the Carter.

When the repair involves **reassembling the used flywheel** (for example, replacement of crankshaft seals due to oil leaks) we must take into account the application of **Ajulock thread locker** Ajusa **75000500** (for more information consult [TIP 111](#)) on the flywheel screws.

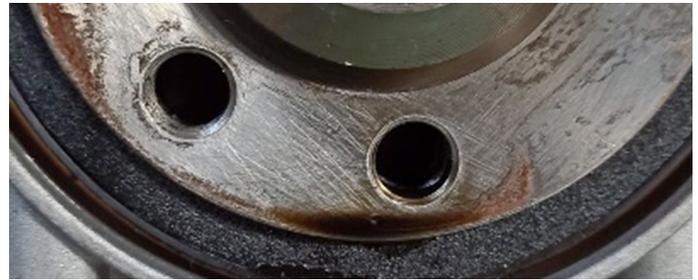
In repairs when disassembling the flywheel it is easy to find oil leakage through the **screw housing** at the bottom of the flywheel (in some engines there is an oil backwater in the lower part of the flywheel).

If any repair involving the disassembly of the flywheel is carried out and these precautions are not taken into account, it can **lead to a loss of oil** in the gearbox area, which is not due to the oil seal.
