TECHNICAL REPORT

Rocker cover gasket for
F8QT Renault engines part
number: 11002800

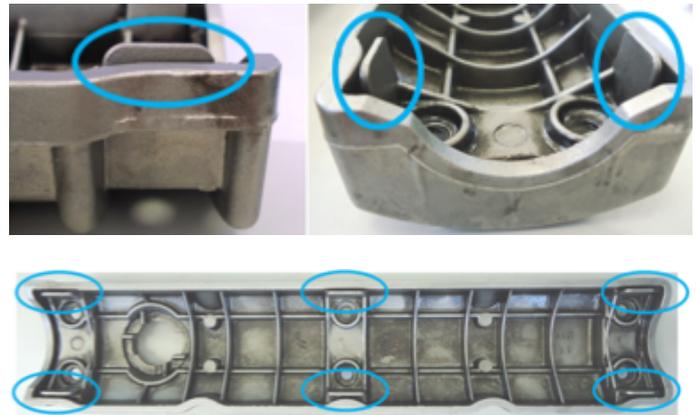
F8QT turbo diesel engines, manufactured by Renault, mount an **aluminum based rocker cover**. This cover has 6 mechanical stops that rest on the cylinder head, and they accomplish two main goals:

- To limit the closing pressure to avoid gasket damage.
- To homogenize the closing pressure against the cylinder head.

As we can see in the above photo, in the same places where the mechanical stops are, we find the holes for the bolts, which are tightened up to a **specific torque** in order to provide a correct seal against cylinder head.

Because of it, mechanical stops suffer the highest pressure against the cylinder head, and because of they are made from aluminum, a relatively weak material, and also due to the re-tighten procedures and vibrations caused by the engine along the years, mechanical stops wear away and reduce their height.

In case of opening the rocker cover, **replace the gasket by a new one and check the state** of the mechanical stops.

If the height of the mechanical stops is not homogeneous and the gasket is expelled when installed, it will be necessary to replace the rocker cover by a new one.
