Service Info

Concentric slave cylinder 510 0133 10

Installation instructions

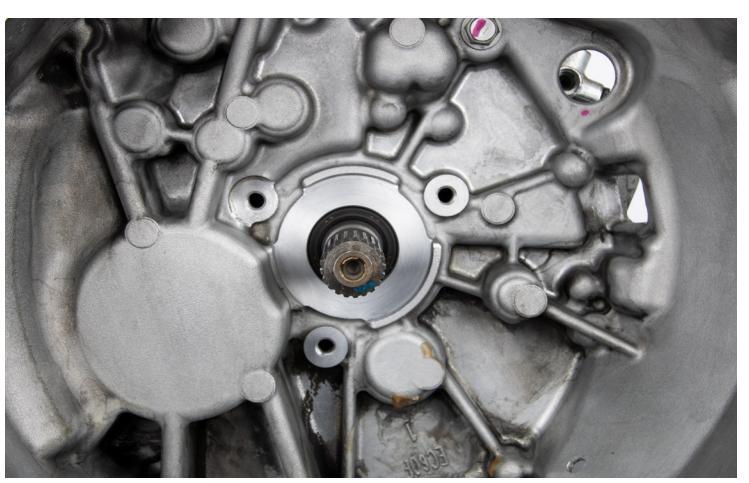
Fig. 1: Contact area of the concentric slave cylinder in the gearbox housing

- The seat of the concentric slave cylinder in the gearbox housing (Fig. 1) must not be damaged
- The contact area must be free of contamination
- When installed, the concentric slave cylinder must lie in full contact with its seat in the gearbox housing
- The screws must be evenly tightened first by hand, the concentric slave cylinder must not be allowed to skew
- Tighten the screws to the torque specified by the vehicle manufacturer

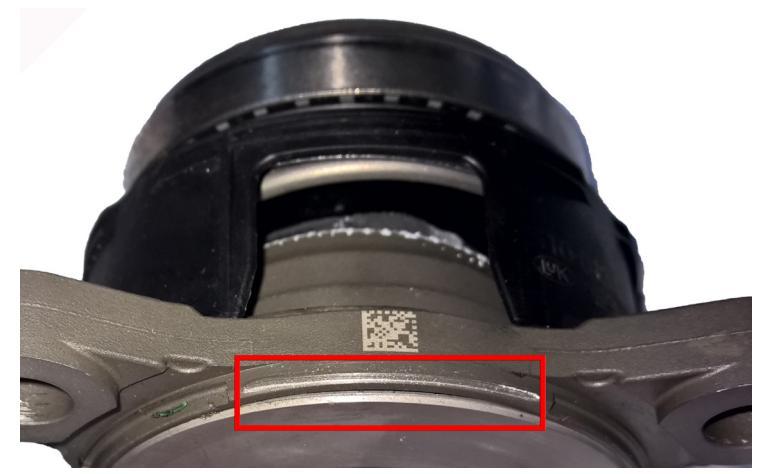
The gasket seals off the hydraulic chamber on the gearbox side of the concentric slave cylinder. If it is not in full contact with the gearbox, hydraulic forces generated during clutch actuation can cause it to separate from the housing. The concentric slave cylinder will leak as a result.

Fig. 2: Damaged concentric slave cylinder with separated gasket
