Caution, when mounting a HBU 1 bearing with different seals

VKBA 7513

PAJERO: PAJERO PININ I (H6\_W, H7\_W)

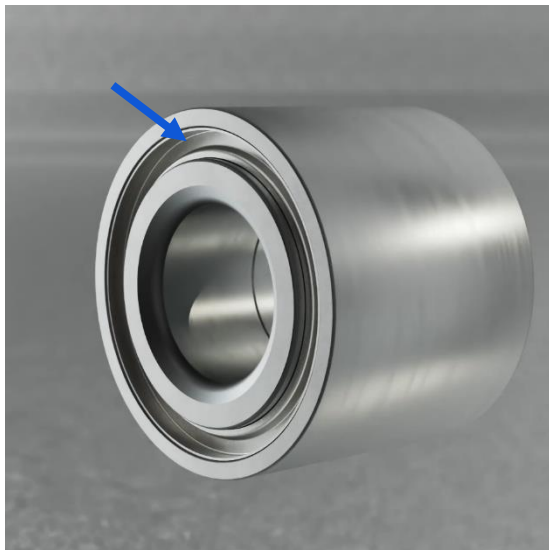
Double bended metal shield –  
outboard side

When installing the bearing, always ensure that the flat seal of the wheel bearing is facing inwards (towards the vehicle) and that the seal with the groove is facing outwards (towards the wheel).  
Note: Always follow the installation instructions provided by the vehicle manufacturer.

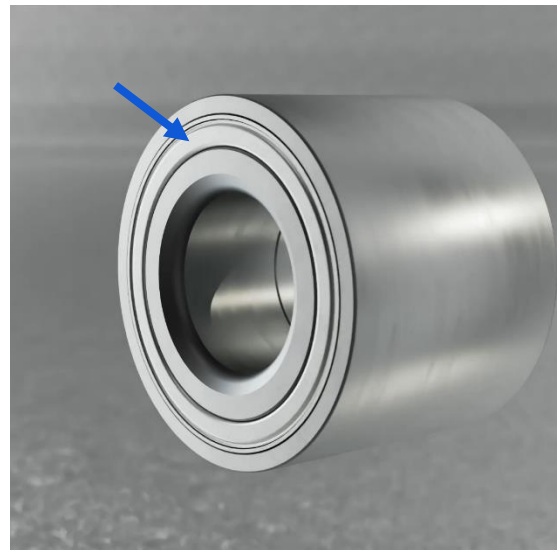
Metal shield with integrated  
rubber seal – inboard side
