# SKF Technical Bulletin

## VKBA 1435 – Fitting Instructions

VOLVO 740, 760, 780, 940, 960

**Fitting instructions: Caution when mounting the Wheel bearing kit VKBA 1435**

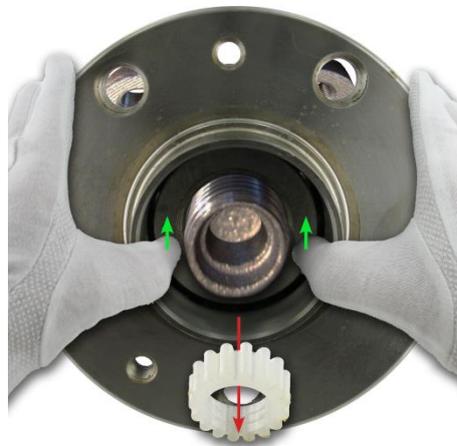
The plastic joining sleeve ring will be automatically pushed out by the axle stub, when mounting the bearing in a correct way, applying the force on the inner ring. Do not push out the plastic sleeve manually before mounting.

- Never remove plastic sleeve before mounting the bearing, as this will separate the inner rings.
- Always use correct mounting tools
- Apply the correct force on the bearing inner ring

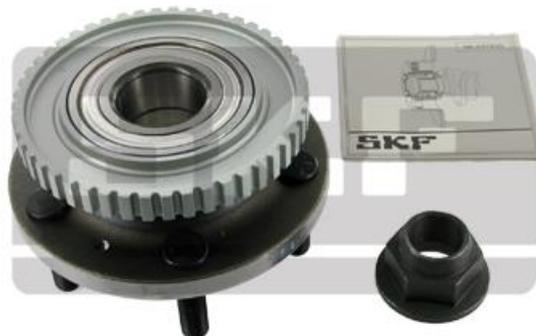
- Wrong tools used
- Wrong mounting
- Wrong applied force

- Bearing inner rings could be separated, despite the plastic secure ring
- Bearing outer rings can move out of the bearing due to the press fit, when the shaft gets pushed through the inner ring
- The balls and raceways will get damaged as the mounting force is transmitted through the balls and raceways.
- Premature bearing failure/damage (due to water ingress....)

- Use correct tools for a proper mounting
- Apply correct force
