Technical Bulletin - November 2011

Chevrolet Epica – Front Wheel Bearing – ABS design check

Technical Information: VKBA 3937

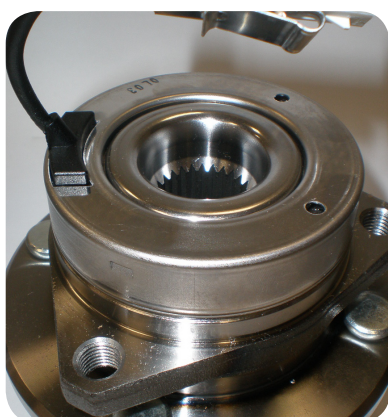
Note: different ABS sensor ring design mounted to back of hub

Design type 1
VKBA 3937 fitment **OK**

Please ensure prior to new bearing fitment. The bearing and ABS design must be checked – compare with old part on car to ensure correct version. This can easily be confirmed by the visual check on back of unit.

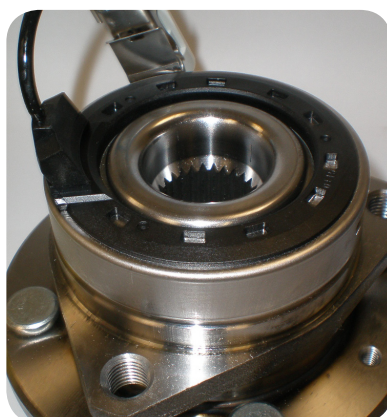
Design type 2
NOT VKBA 3937
