SKF Technical Bulletin

VKBD 1015 – Fitting Instructions / Mandatory replacement of the nut

RENAULT Clio III/Grandtour, Megane II, Modus/Grand Modus, Twingo II, Wind

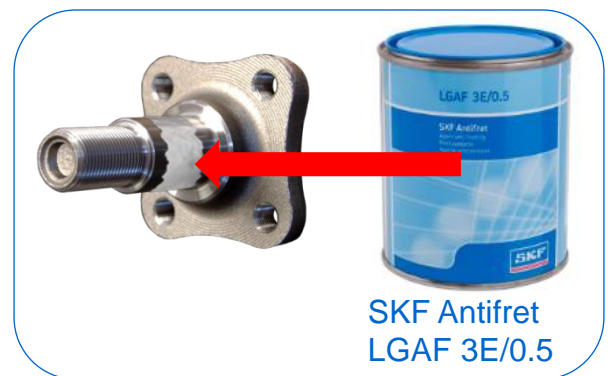
Clean the axle stub from all dirt and pollution. To avoid rust after mounting, always use SKF Antifret (LGAF 3E/0.5) on the stub axle before mounting the bearing.

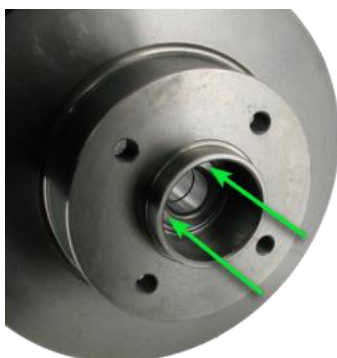
When installing the bearing and the brake disc, apply the force **ONLY** on the inner ring of the bearing.

- Wrong tools used
- Wrong applied force
- Re-use of the old mounting nut

- Bearing inner rings could be separated during mounting
- Balls, tapers and raceways are damaged
- Premature bearing failure/damage (due to water ingress....)

- Use proper tools
- Apply correct force
- Use the new nut contained in SKF kit as specified on the warning sticker on SKF box
