LuK GearBOX, Part number: 462 0195 10

Transmission Data

- ▶ **Manufacturer:** Volkswagen Group
- ▶ **Type:** 0AH
- ▶ **Design:** 5-speed manual transmission

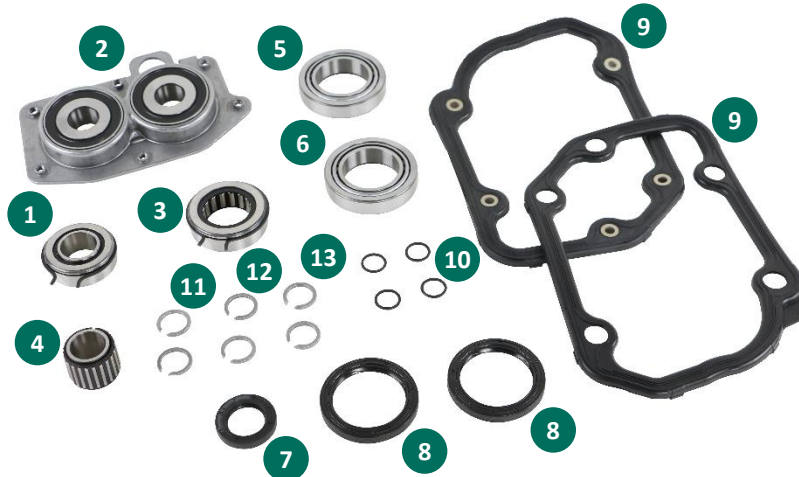
Box Content

No.	Description	Mounting Position	Part	Dimensions (mm)
1	Main bearing input shaft	Engine side	Roller bearing	24.10 x 47.00 x 17.70
2	Main bearing in-/output shaft	Gearbox side	Double ball bearing	172.00 x 108.00 x 38.00
3	Main bearing output shaft	Engine side	Roller bearing	32.00 x 55.00 x 18.00
4	Idler gear bearing and inner ring 5th gear	Gearbox side	Needle roller bearing	21.80 x 32.00 x 25.80
5	Main bearing differential	Engine side	Tapered roller bearing	41.00 x 68.00 x 18.30
6	Main bearing differential	Gearbox side	Tapered roller bearing	41.00 x 68.00 x 18.30
7	Seal ring input shaft	Engine side	Shaft sealing ring	
8	Seal rings differential	Engine/Gearbox side	Shaft sealing rings	
9	Seal cover 5th gear		Flat gaskets	
10	Seal bearing journals		O-rings	
11	Circlip 5th gear		Adjusting ring	17.70 x 2.00
12	Circlip 5th gear		Adjusting ring	17.70 x 2.10
13	Circlip 5th gear		Adjusting ring	17.70 x 2.20

- ▶ A typical failure is wear of the bearing shaft seat with double ball bearing which will be indicated by a rattling noise. This can result in the failure of the 5th gear needle roller bearing (see No. 4).
- ▶ Due to different vehicle applications of the VW 0AH transmission there are two LuK GearBOX sets (462 0195 10 / 462 0196 10). These sets differ in the gearbox-side bearing of the input and output shaft (double bearing with cast or sheet metal housing).
- ▶ The exact part number is determined by the transmission ID.
- ▶ Repair instructions are available from the vehicle manufacturer.
