## SWAG 50 92 6770

to fit:  
Ford Focus and  
C-Max Models

## Wheel Bearing Kit with Wheel Hub and ABS Sensor Ring

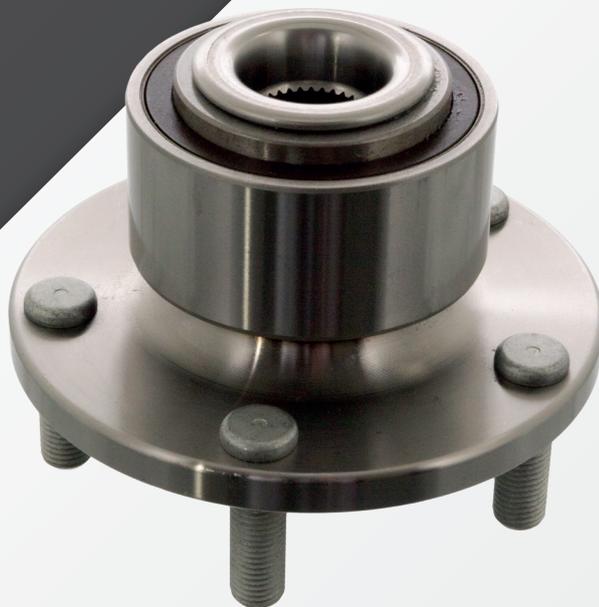
Anti-lock brake system (ABS) warning lamp is illuminated and the following fault codes are logged into the ABS module:

- C1141 front left wheel speed sensor/ring gear defective
- C1142 front right wheel speed sensor/ring gear defective

Loss of wheel speed signal to the ABS system due to excessive front wheel bearing movement and inadequate fitment of the bearing in the wheel knuckle assembly.

Replace the defective wheel bearing, ensuring that the mating surface in the wheel knuckle assembly is thoroughly clean and dry and is free from grease, debris, and corrosion. In order to prevent the bearing moving in the wheel knuckle bore when installing the new bearing, clean the contact surface and apply a thin film of sealant, such as a thread lock (30 92 6709 or 30 92 6710), to the mating surfaces of the bearing and wheel knuckle bore before pressing the new bearing into the knuckle.

After assembly, reset all fault codes and test to ensure for the correct operation of the brake system.
