SWAG 10 92 2688

to fit:
Mercedes-Benz C-Class (W202)

Windscreen wiper motor

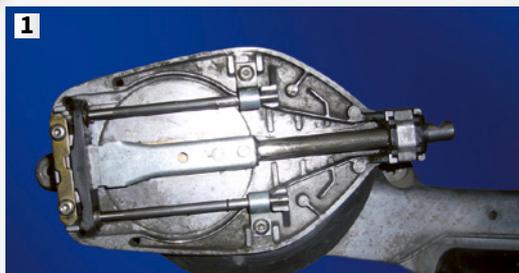
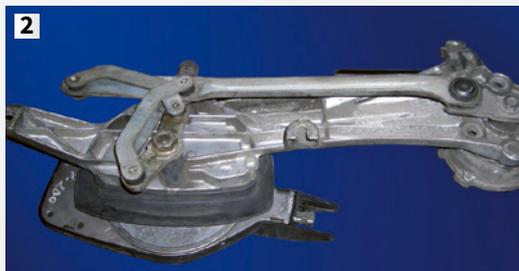
The windscreen wiper motor operates linkages and a lifting mechanism for driving the windscreen wiper arm (see photos 1 and 2). These components may become stiff due to external factors. The toothed wheel of the motor is made of plastic and can easily become damaged (see photos 3 and 4). If the toothed plastic wheel is faulty, the worm gear will no longer operate the toothed wheel to the full extent. This means that the windscreen wiper no longer works properly, makes a noise and/or fails to function completely.

SWAG recommends checking linkages and lifting pistons for freedom of movement prior to fitting windscreen wiper motor SWAG 10 92 2688. This may prevent the windscreen wiper motor from failing prematurely.
