SWAG 33 10 1501

To Fit: Audi A3 (8V), Q2 (GA)
SEAT Ateca (KH), Leon (5F)
Škoda Karoq, Kodiaq, Octavia III, Superb III
VW Atlas (CA), Golf 7 (5G, BQ, BA, BV, AU,
AM, AN, BX), Teramont (CA),
Tiguan 2 Allspace (BW2),
Touran 2 (5T)

Ignition Switch

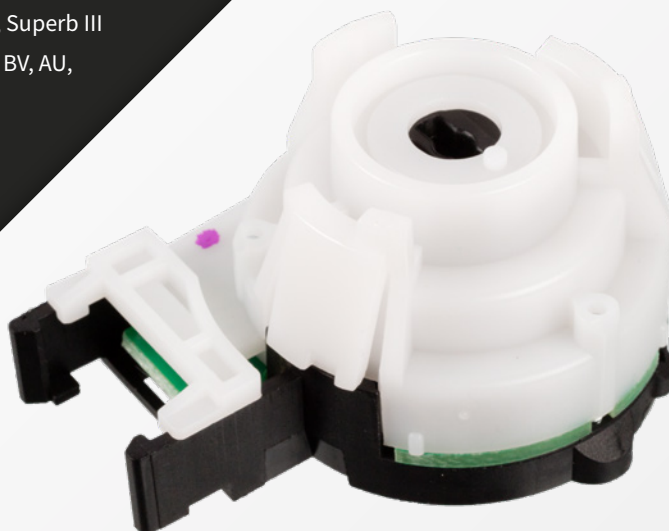
The engine remains running when the ignition key is turned to the 'off' position but stops when the key is removed. Using a suitable diagnostic tool can show the following fault codes:

A fault can occur in the switch caused by internal tolerance issues which prevent the contacts from aligning correctly.

Check the continuity of the wiring loom to the ignition switch. If the readings are correct then proceed with changing the ignition switch. SWAG replacement part 33 10 1501 is manufactured to match the latest (modified) version. SWAG also has the ignition lock housing in range under article number 30 93 6044.
