# Jeep Grand Cherokee

## Rear Wheel Bearing Replacement

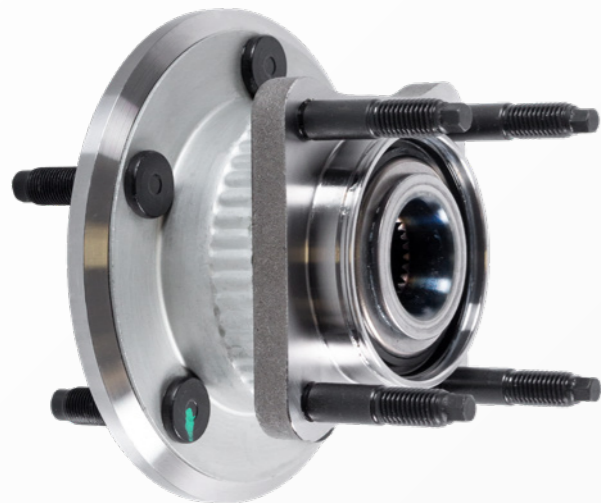
Figure 1

The preassembled SWAG wheel bearing kit 33 10 3863 was chosen for this repair. This comes complete with wheel and axle studs and the bearing is preloaded and greased ready for assembly to the vehicle. (Fig. 1)

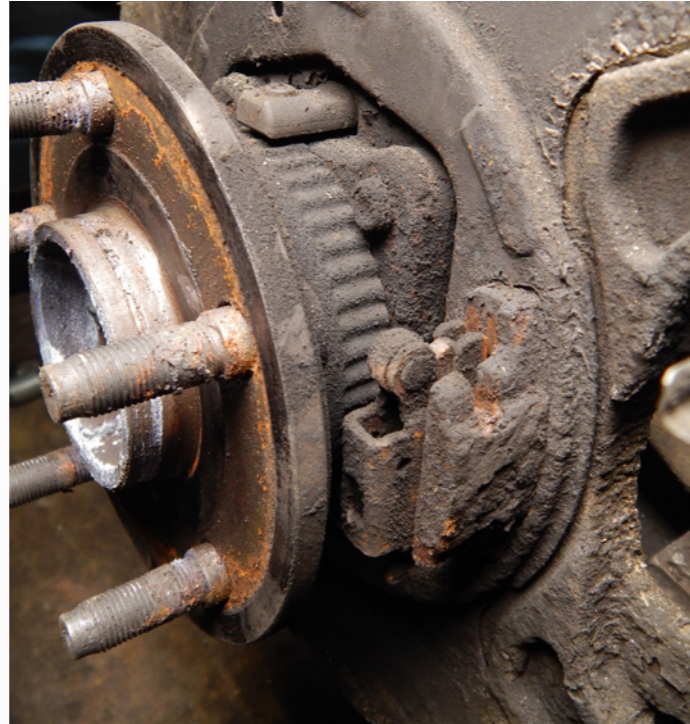
Figure 2

The handbrake actuator lever was removed from the cable, inspected, and checked for excess corrosion and freeness of operation. (Fig. 2)

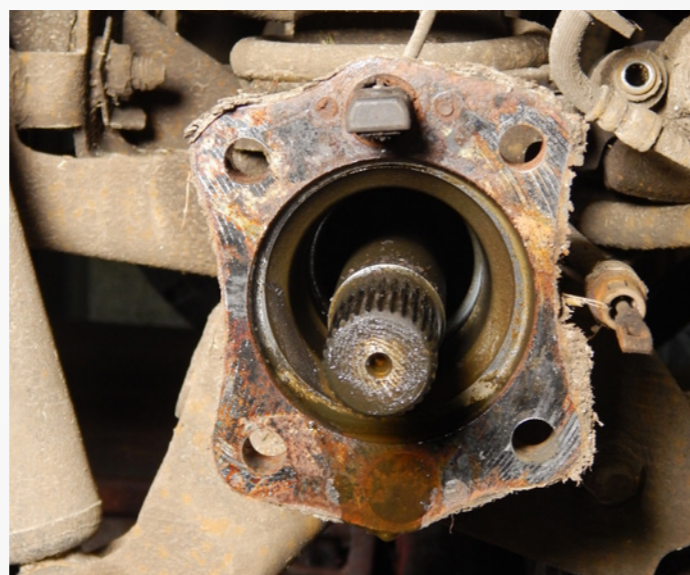
Figure 3

With all the brake components removed, the four retaining nuts that retain the bearing assembly to the axle were unbolted. The bearing assembly then came away, leaving the ABS wheel speed sensor in place. (Fig. 3)

However, the brake shoe backing plate and brake caliper carrier remained attached. In some instances, there is also a possibility that the half shaft also remains attached, which then requires sliding out of the bearing and reinserting back into the differential in the axle.

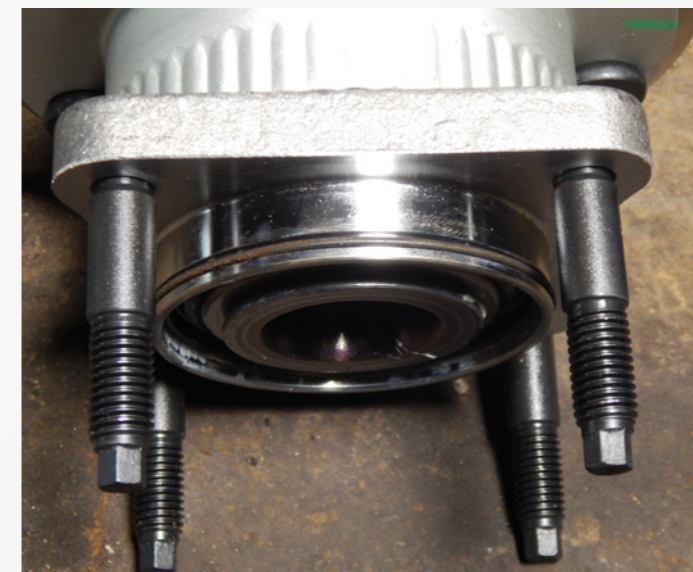
Figure 4

Once all the parts were ready for assembly, they were fitted to the new bearing assembly along with the "O" ring seal positioned in the retaining groove on the bearing (Fig. 4).

Note: Failure to fit this "O" ring can cause axle oil to leak past the bearing, affecting the brake shoe linings.

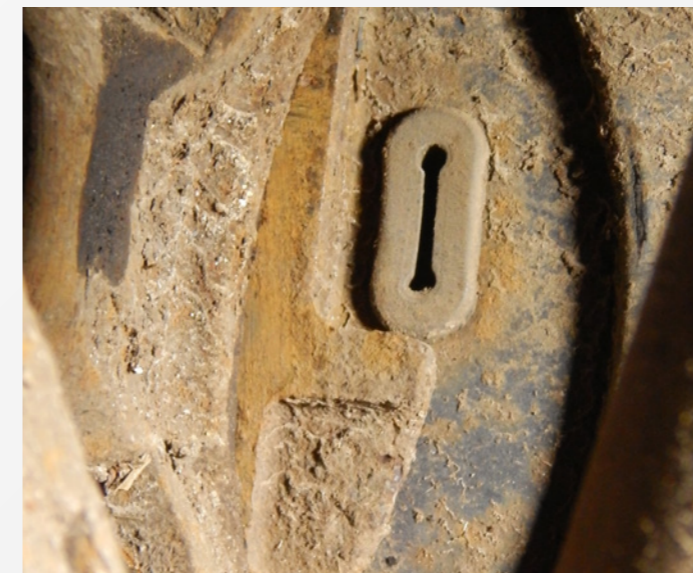
Figure 5

Note: If any adjustment is required, remove the plug from the access hole in the brake back plate. (Fig. 5) Then, loosen the parking brake cable adjustment nut until there is slack.

A suitable adjusting tool should be inserted through the back plate access hole to engage a tool in the teeth of the adjusting wheel. Rotate the adjuster until a slight drag can be felt when the road wheel is rotated.
