## OIL PUMP FOR 1.8 & 2.0 TFSI ENGINES

OIL PUMPS | 11402

**V10-4899**

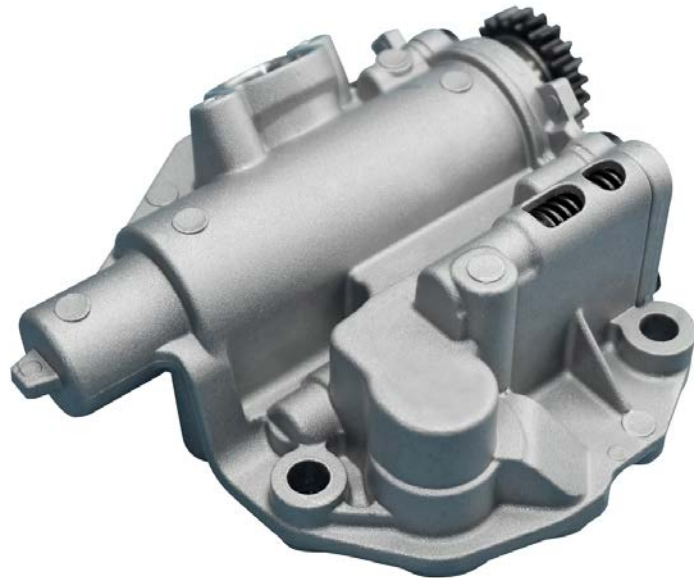
In all common combustion engines, the oil pump ensures sufficient oil pressure and thus the lubrication of all moving components of the unit. However, the oil pumps in Volkswagen's TFSI engines are particularly susceptible to damage. If the vehicle has not been moved for a long time at low temperatures, clicking noises may come from the engine compartment when the engine is started or shortly afterwards, indicating the defective oil pump. In this case, it is advisable to replace the oil pump as soon as possible to prevent consequential damage to other components.

- Clicking noise from the engine compartment after starting the engine

- Increased wear due to insufficient oil pressure
- Engine damage

- Vehicle is parked for a long time in low ambient temperatures
- Faulty oil pump

- Renew oil pump
