Service Info

Wheel bearing repair solution for transporters

Using the special tool 400 6199 10

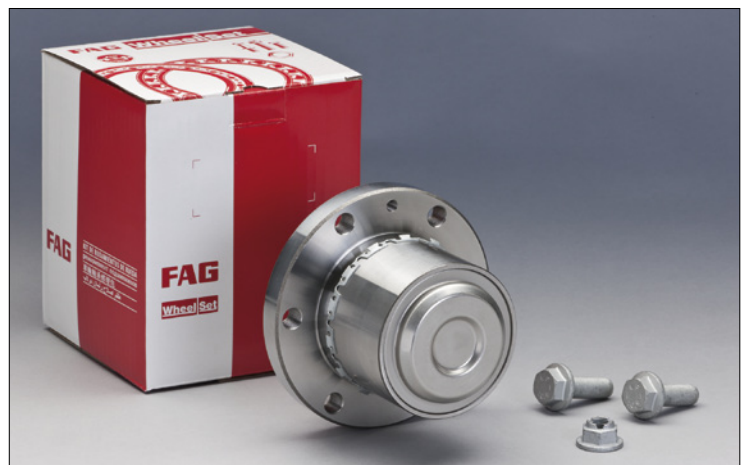
Image 1: The wheel bearing unit can now be replaced individually

For the first time, it is now possible to replace the wheel bearing of the front axle of the vehicles listed above without having to replace the entire steering swivel assembly.

In contrast to the repair methods suggested by the manufacturer, Schaeffler Automotive Aftermarket now offers an inexpensive repair option. The otherwise mandatory wheel alignment is no longer necessary and the associated downtimes of the vehicle in the workshop are reduced.
