Service Info

Truck Hub Unit (THU)

Observe installation orientation

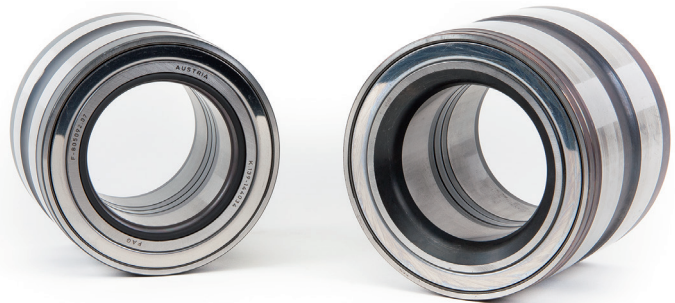
Fig 1: Truck Hub Unit with seal ring (left) and beveled edge (right) on the bearing inner ring

The bearing units listed above must be installed in the correct orientation. Although this is determined by the shape of the axle journal and by the shape of the bearing inner ring of the THU, this Service Info is provided for further clarification.

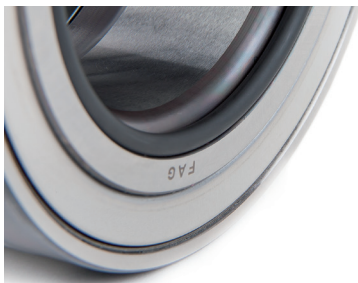
Fig 2: Truck Hub Unit with o-ring

The key difference can be seen on the bearing inner ring. Some bearing units have an o-ring (Fig. 2) on the inner face, where other bearings have a beveled or rounded edge (Fig. 3). The following table lists the feature and the installation orientation of the bearing units.

Article number	Feature / installation orientation
805003CA.H195 805011C / 805011.03.H195 805012.06.H195 805092.07 / 805092.07.H195	o-ring / faces inward
571762.01.H195 803194.26 / 803194.26.H195 805003A.H195	Beveled edge / faces inward

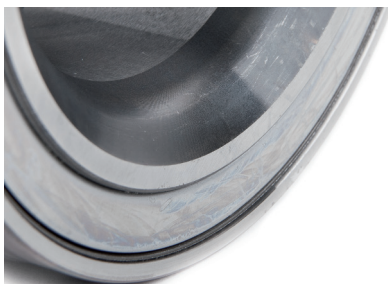
Fig 3: Truck Hub Unit with beveled edge
